**Przebieg i przyczyny endogenicznego pożaru węgla kamiennego  
na zrehabilitowanym składowisku odpadów komunalnych w Katowicach  
(patrz str. 764)**

**The cause and progress of the endogenous coal fire in the remediated landfill  
in the city of Katowice (see p. 764)**

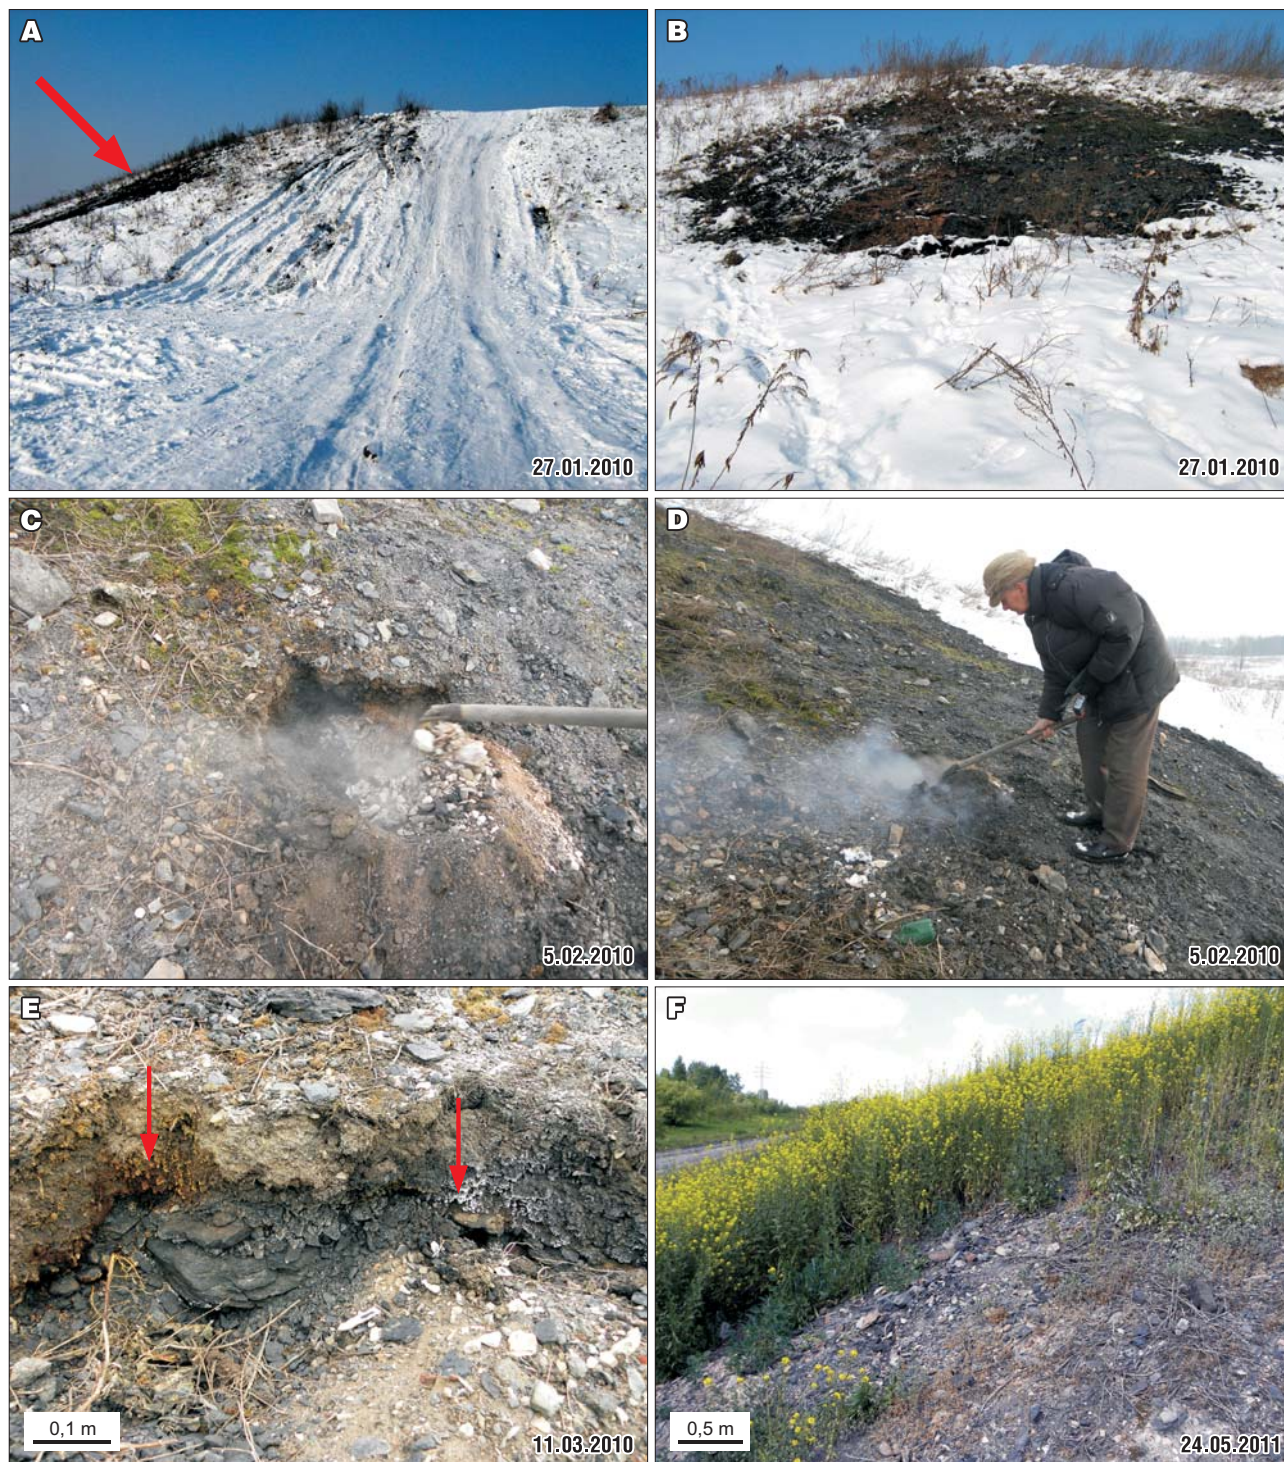
**Ryc. 5.** Skarpa południowo-zachodnia: **A** – nowo powstałe pole 50 o średnicy ok. 15 m (wskazane strzałką); **B** – szadź oraz para wodna w lewej części pola 50; **C** – przepalony pomarańczowo-różowy okruchy skał; **D** – zapożarowanie dolnej części pola 50. Na głębokości 30 cm temperatura wynosiła 460°C; **E** – wykwitki siarki (żółte) oraz salmiaku (białe) u ujścia szczelin ekshalacyjnych; **F** – bujna roślinność rosnąca wokół pola 50. Ryc. 5A–F fot. J. Ciesielczuk

**Fig. 5.** South-western slope: **A** – newly formed hot spot 50, 15 m in diameter (marked by arrow); **B** – frost and water vapour in left side of hot spot 50; **C** – pinkish colour of overburned rock debris; **D** – smoldering fire in lower part of the hot spot 50. Temperature at a depth of 30 cm b.g.l. was 460°C; **E** – efflorescences of sulphur (yellow) and sal ammoniac (white) at venting fissures; **F** – lush vegetation around hot spot 50. Figs. 5A–F photo by J. Ciesielczuk
