# **HELLENIC SURVEY OF GEOLOGY AND MINERAL EXPLORATION (H.S.G.M.E.)**

## **Palaio Mikro Chorio LANDSLIDE**

**U-Geohaz & EOEG field trip**

**4th and 5th of June 2019, Athens, Greece**

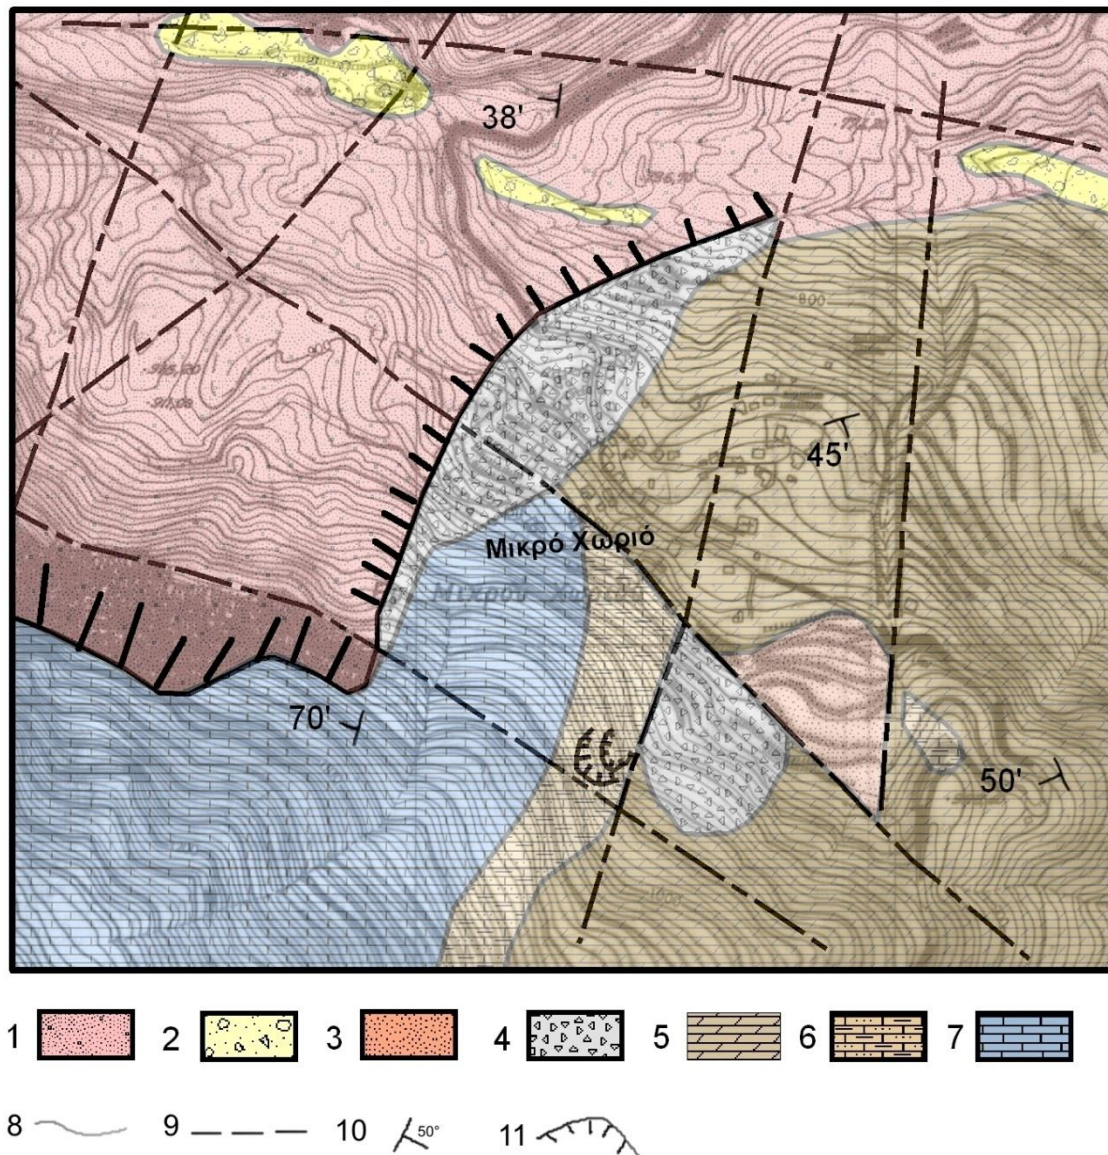
The wider residential area is constructed of flysch sediments, limestone transition layers to the flysch, thin plated limestone and shale-cherts (Fig. 1). At the lower morphological levels, the presence of quaternary formations, which are distinguished in landsliding masses (materials of old slides), screes (old and new) composed by limestone, shale-chert fragments, as well as river deposits in the adjacent torrents (Fig. 2).

Figure 2. Engineering geological map of Palaio Mikro Chorio wider area.

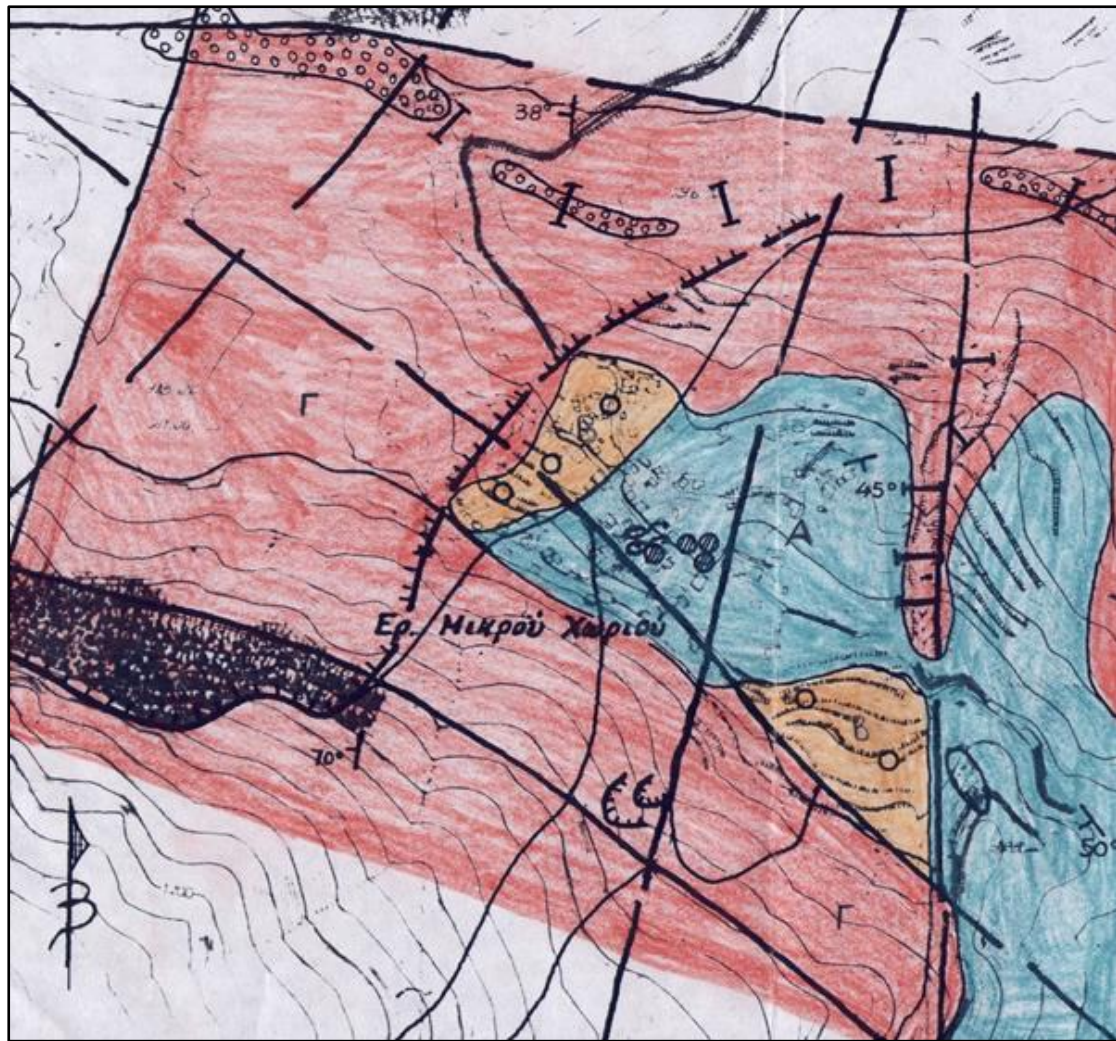
Micro Chorio was one of the reexamined settlements and the housing suitability map is shown in Fig. 3.

Figure 3. *Housing suitability map of Palaio Mikro Chorio wider area.*

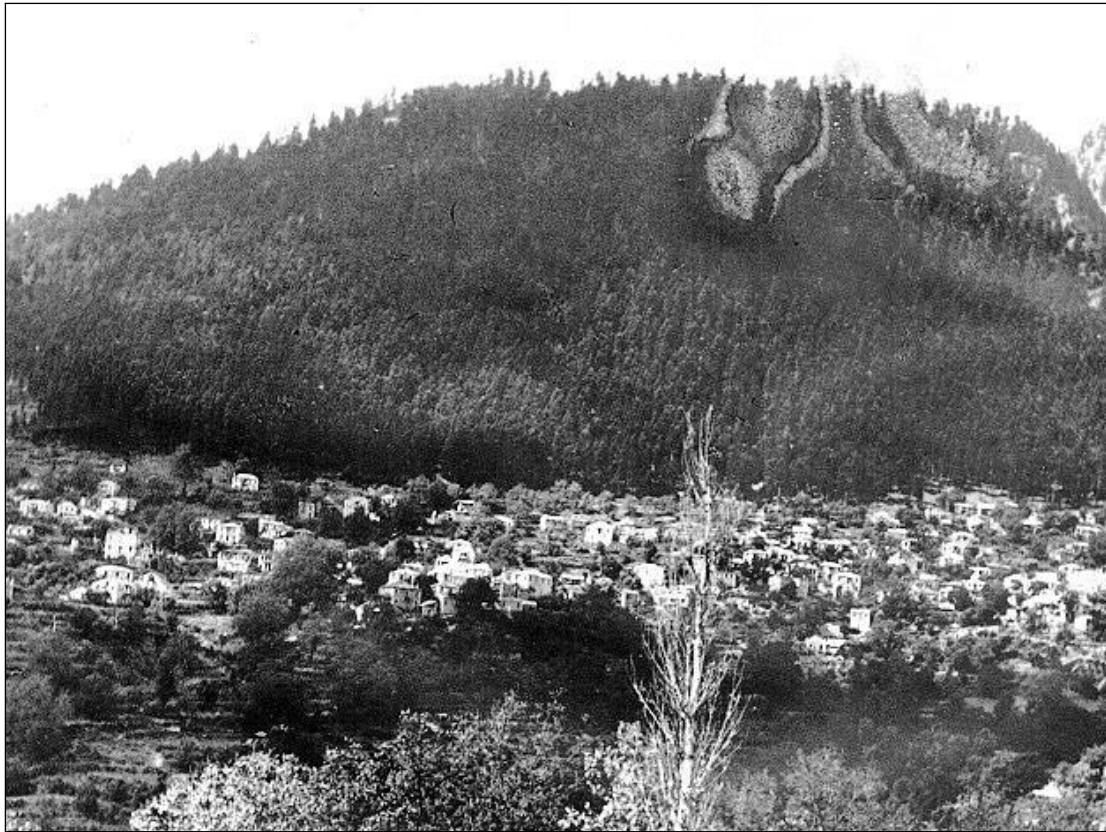
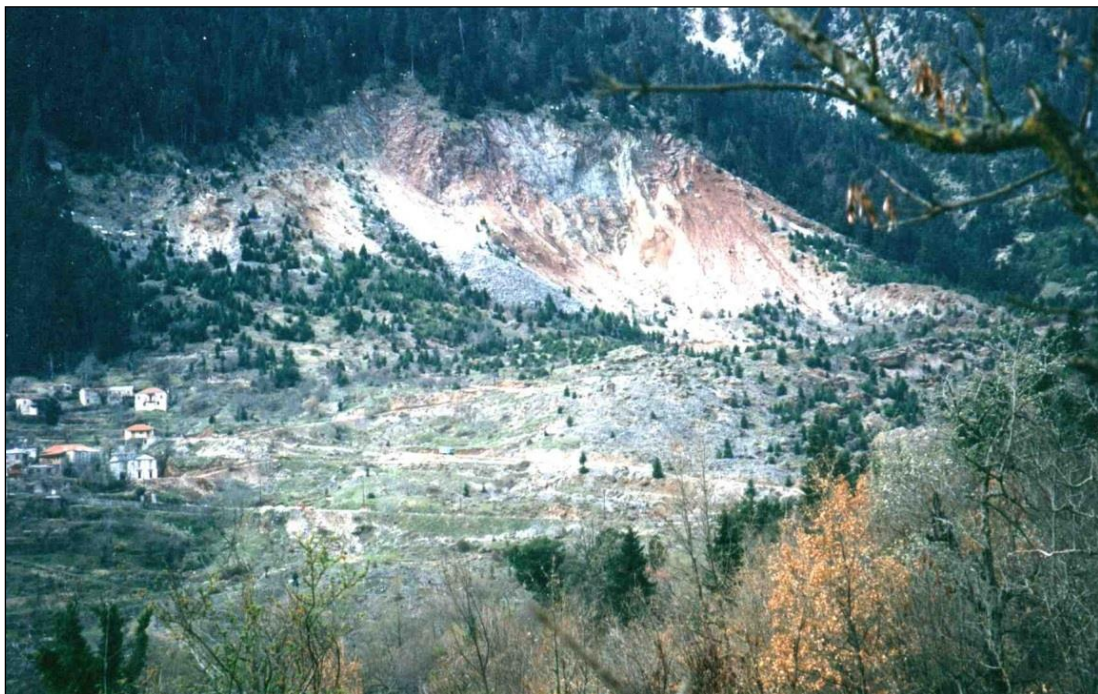
On the 13th of January 1963, a major landslide destructed the largest part of the settlement with huge consequences, causing 13 dead people.

*Photo 1. General view of the Palaio Mikro Chorio before the 1963 landslide (a) and after (b).*

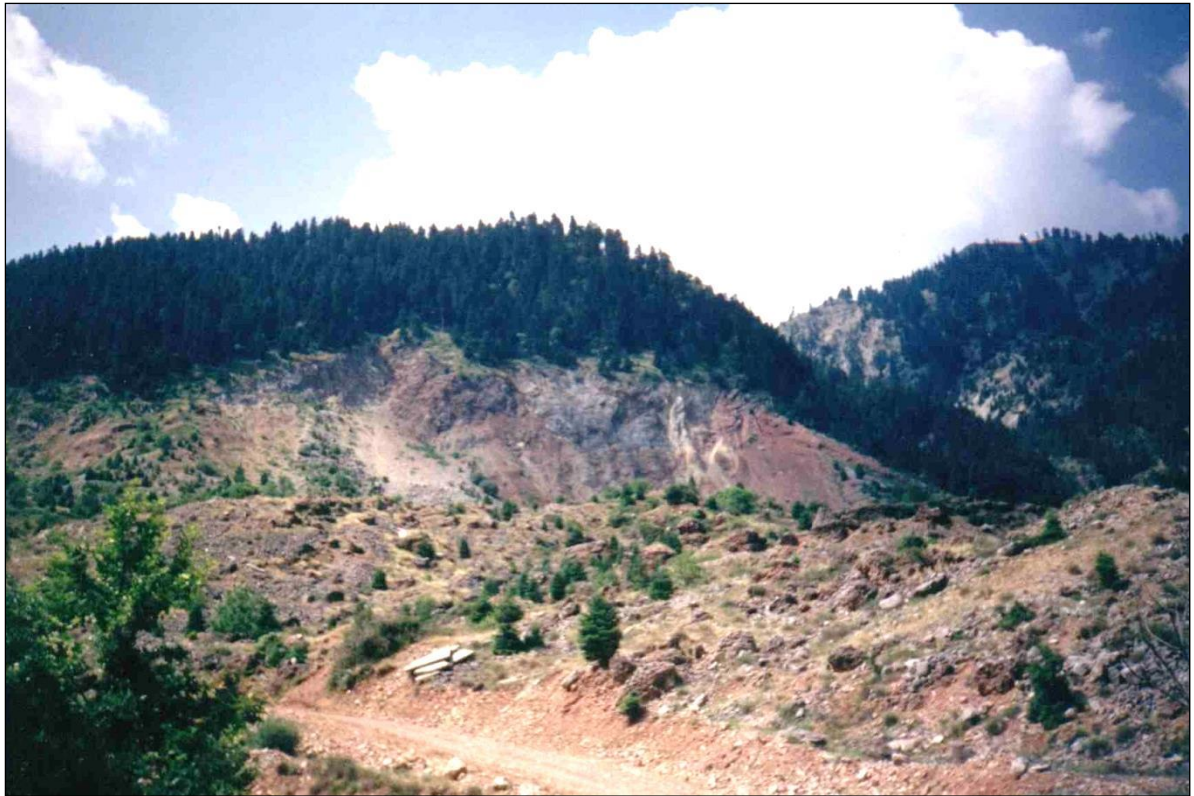
The landslide affected predominantly the scree, which at the failure site had considerable thickness. The landslide affected also the basement formations as the slip plane followed major discontinuities (probably shear zones) present in the area. The current situation reveals a detachment front with a 20-30m height where the basement formations (mainly limestones and shale-chert) can be seen.

*Photo 2. Landsliding masses (materials from old slides). In the background, the front of the detachment is visible.*

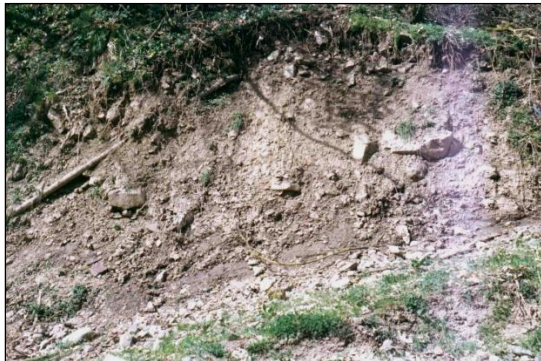
*Photo 3. Weathering mantle.*

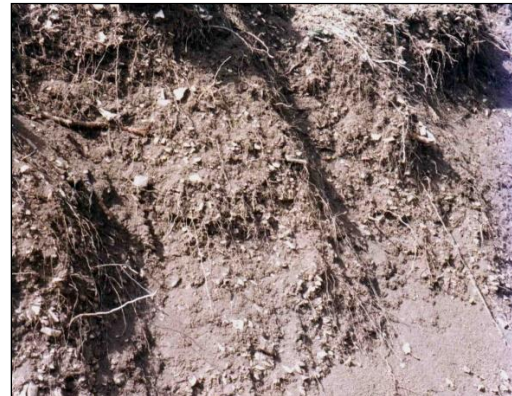
*Photo 4. Lateral Screes.*

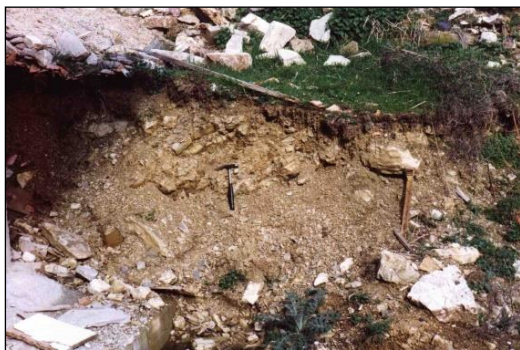
*Photo 5. Flysch sediments.*

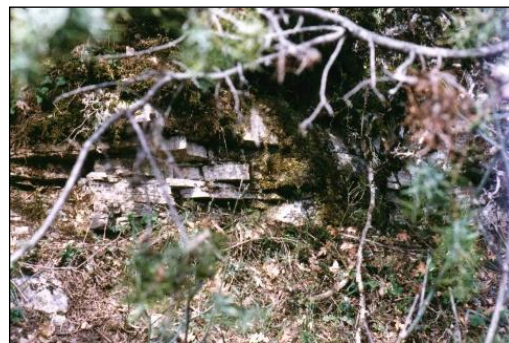
*Photo 6. Transition zone beds from the carbonate sediments to the flysch.*

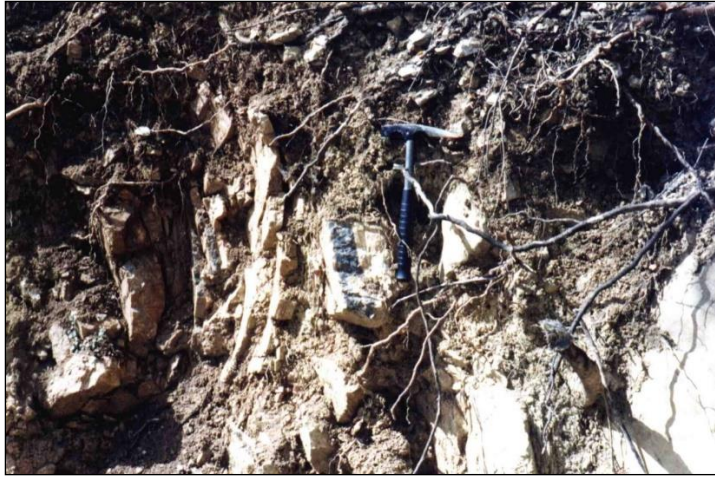
*Photo 7. Thin plated limestones with hornstone.*
