## GEOLOGICAL STRUCTURE OF THE SOUTHERN BALTIC COAST AND RELATED HAZARDS

**Abstract.** Polish coast of the Baltic Sea has a total length of 498 km (without internal lagoons coasts). Quaternary deposits dominate coastal zone, similar to central and northern Poland. According to morphology and geological structure, three types of coast are distinguished: cliffs (c. 101 km), barriers (380 km) and coast similar to wetlands (salt marshes) (c. 17 km). Generally, three types of mass movements can be distinguished on cliff coast: eboulements (rock falls) dominated on the cliffs built mainly by tills, talus and landslip, dominated on sandy cliffs, and typical landslides occurred on cliff stretches with a complex structure where the main role play clay layers being initial slide layers for other deposits. Serious risks are related to erosion of low and narrow barriers, which could be easily broken during storm surges. Storm floods in case of barrier being broken threaten lowlands behind the barriers. Similar flood hazard exists also on lagoon coasts located behind large and relatively stable barriers. It is caused by barographic high water stands, which in extreme cases reach up to 2 m abov

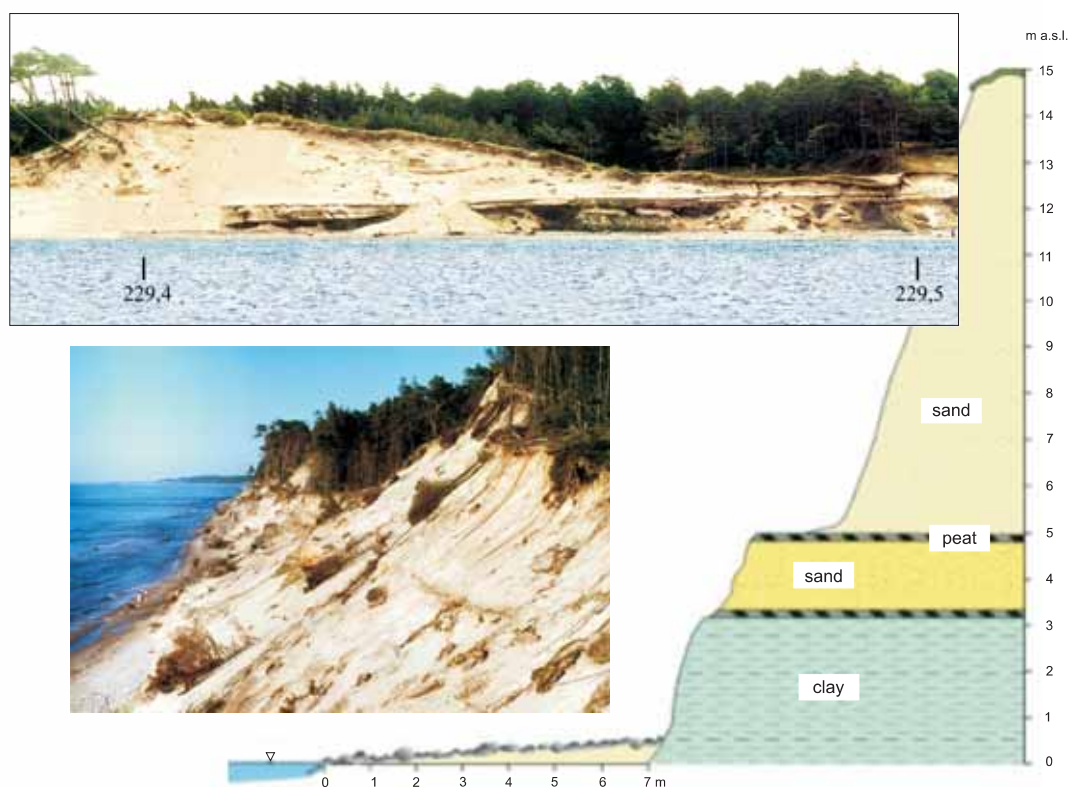
Fig. 3. Geological profile of the cliff dominated by sandy layers east from Ustka (middle Polish coast) and taluses and landslips

Most dangerous for hinterland are catastrophic events related to mass movements. Generally, three types of mass movements can be distinguished on Polish coast: eboulements (rock falls) dominated on the cliffs built mainly of tills (Fig. 2), talus and landslip dominated on sandy cliffs (Fig. 3) and typical landslides occurred on cliff stretches with a complex structure, where the main role play clay layers being initial slide layers for other deposits. Landslides are most hazardous on the coast because, opposite to eboulements and taluses, affected sometimes zone of hundreds metres away from the cliff edge.

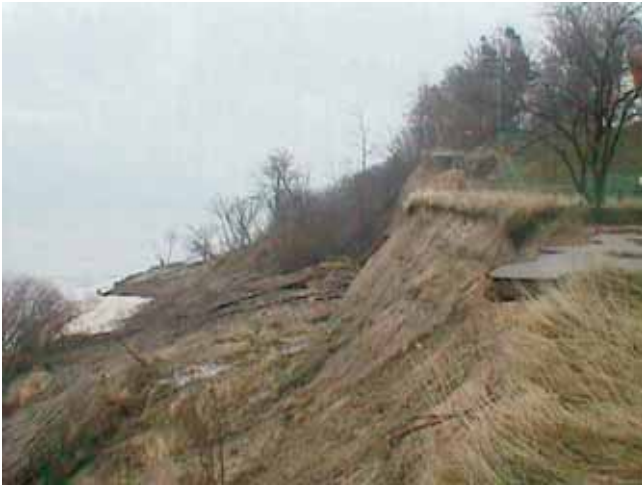
**Fig. 5. Landslide on Jastrzębia Góra Cliff, January 1999**  
(Photo. by Sz. Uścińowicz)

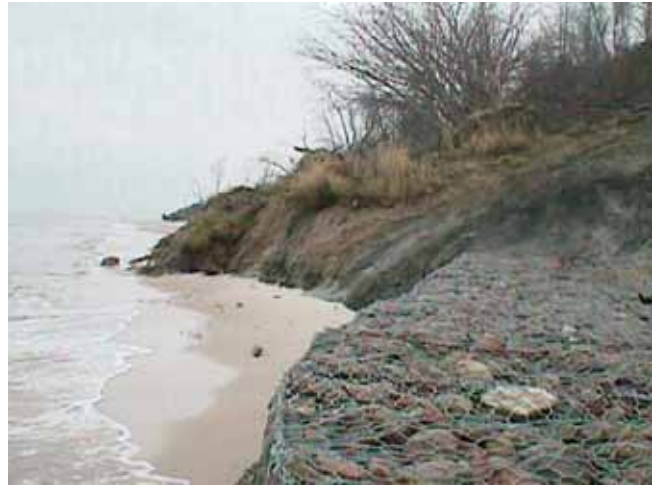
**Fig. 6. Seawall built in 1994 for protection of the cliff, partly destroyed by landslide in January 1999**  
(Photo. by Sz. Uścińowicz)

of colluvium erosion at the cliff foot slope, for the period of 1977–1990, was 0.94 m/year. Till to 1994, the cliff in Jastrzębia Góra was not protected by any hydrotechnical constructions or other methods. In 1994, a sea wall was constructed for protection of the cliff's foot slope against the marine erosion. The marine erosion was stopped but mass movements on the cliff still have occurred. A large landslide took place in January 1999 (Fig. 5). And sea wall was partly destroyed (Fig. 6). During the year 2000, a stepped stony wall was built for protection of the cliff's slope (Fig. 7). The open question still is: is it the best solution for all the eroded cliff's sections on Polish coast?

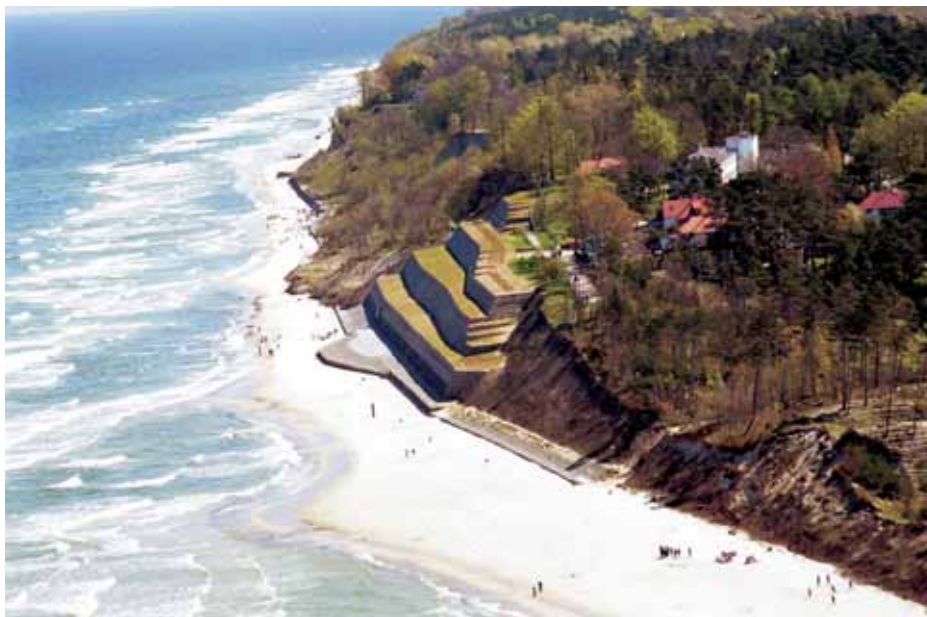
**Fig. 7. Stepped stony wall protecting of the Jastrzębia Góra cliff's slope, built in 2000, and new landslide behind the wall** (Photo. by P. Domaradzki, 2001)

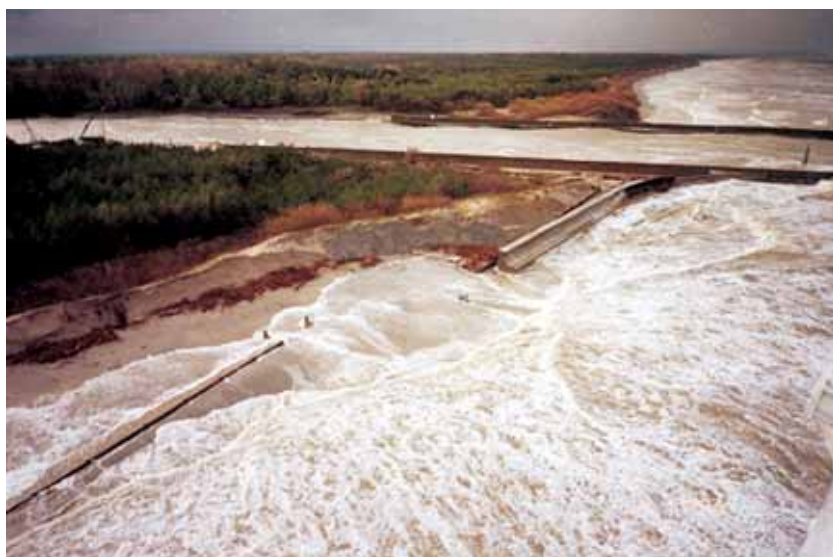
**Fig. 8. Braking of Dziwnów Barrier (western Polish coast) during the storm in November 1995 (Photo. by P. Domaradzki)**

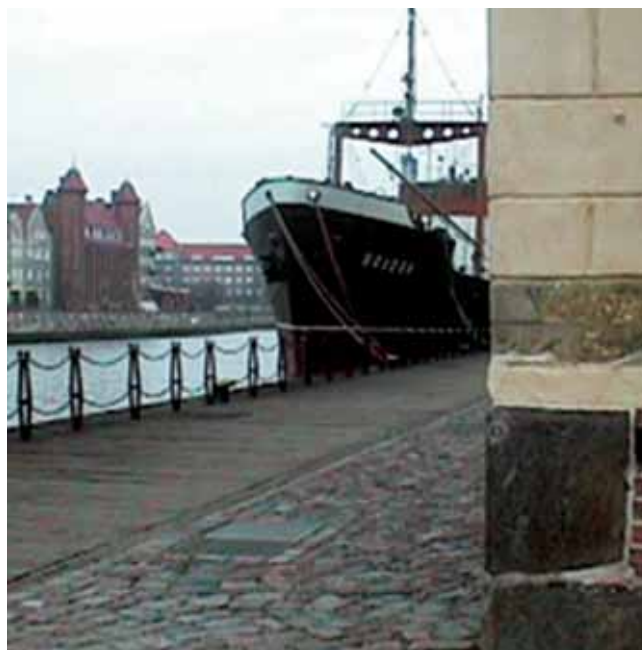
**Fig. 9.** Mark of the highest water stand on the wall of old granary, indicating 3.36 m above the mean sea level

in the Vistula coinciding with the spring high water stages and superposing with strong, lasting, northern winds generating storm surges and causing invasion of Baltic waters into Vistula mouth. In unfavourable conditions, the rise in sea level may exceed 1.5 m. The last catastrophic flooding in Gdańsk occurred in April 1829, when 75% of the contemporary city area was under water. Up to the present days, five marks of the highest water stand survived on the walls of buildings in the Old Town indicating high water at 3.36 m above mean sea level and c. 1.5 m above the ground (Fig. 9). Also after the Second World War, a part of the city was flooded because of damages of dykes and dams in the area of Vistula Delta Plain. In the near future, the flood hazard would increase because of accelerated sea level rise and increased frequency of heavy storms. The large and important parts of the city, like port facilities, urban districts, industry, warehouses, transportation routs, sewage and drainage water system and sewage plants as well as groundwater intakes are vulnerable to accelerated sea-level rise and endangered by flooding. Some historic buildings in Gdańsk in the low laying part of the Old Town and some of groundwater intakes are threatened directly. During the last years, there were observed rise of groundwater level. For example, water appeared at the cellars of several buildings. Also intrusion of salt water into the fresh water aquifers was observed.
