REPLACEMENT OF A FAILED SHOTCRETE FACING BY A FLEXIBLE SLOPE STABILISATION SYSTEM

Abstract. The alignment of a new highway from Igoumenitsa to Evros in the north of Greece required several massive cuts in soil slopes. Mainly due to erosion and creep movements within the superficial layer of a cut soil slope, the shotcrete facing failed. The friction forces as a result of interaction between shotcrete facing and soil surface caused an overstraining of the stiff facing, and finally its collapse. The shotcrete was removed and replaced by a flexible slope stabilisation system consisting of a high-tensile steel wire mesh cover in combination with an adequate nailing. Flexible slope stabilisation systems are widely used to stabilize soil and rock slopes. They are economical and a good alternative solution to stiff measures with shotcrete or massive structures with the possibility of reintroducing vegetation. Special concepts have been developed for the dimensioning of flexible slope stabilisation systems considering superficial instabilities. Numerous implemented cases in soil as well as in rock with and without vegetated faces confirmed that these measures were suitable for practical a

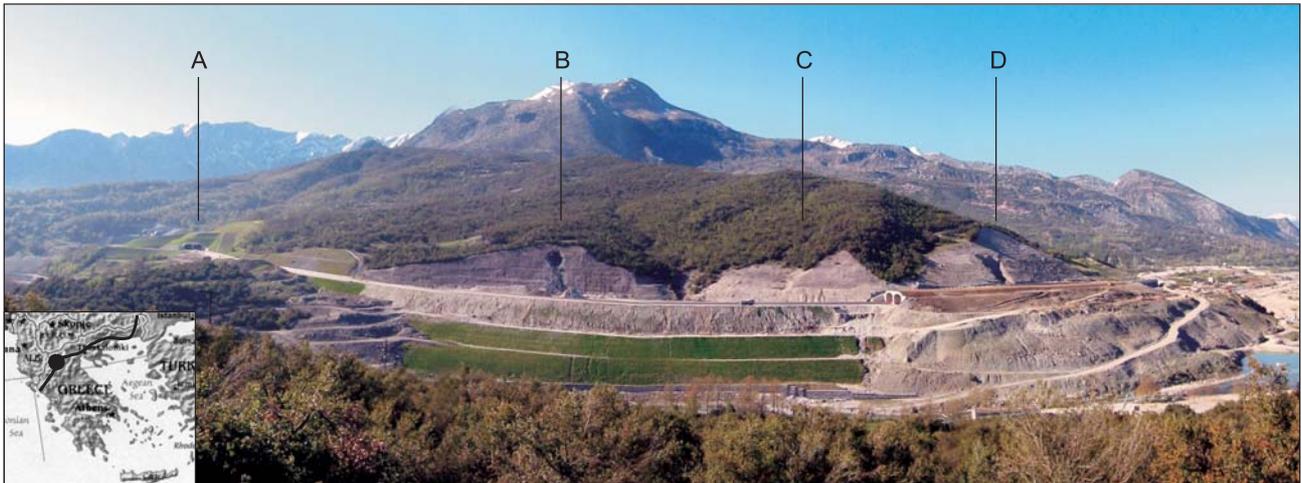
Fig. 1. Project overview looking south of Egnatia

The recultivated slope cutting is situated near Peristeri, Greece, above a tunnel open pit constructed at an altitude of about 720 m a.s.l. (location A, Fig. 1). The inclination of the stabilised 420 m long slope, 40 m high at the entrance area as well as 18 m above the covered tunnel, amounts to 40–60°.

The area of interest is the location A (Fig. 1) (ch. 4+511–ch. 4+616) where sandstones are prevalent. Geologically, the area is structured by flysch of Pindos zone. Tectonically, the flysch is intensely folded and sheared. On the surface, the flysch is weathered and shattered down to a 6 to 7 m depth. Seasonal perched water tables are developed in the surface of the loose and shattered flysch zone. The erosion caused by Metso-

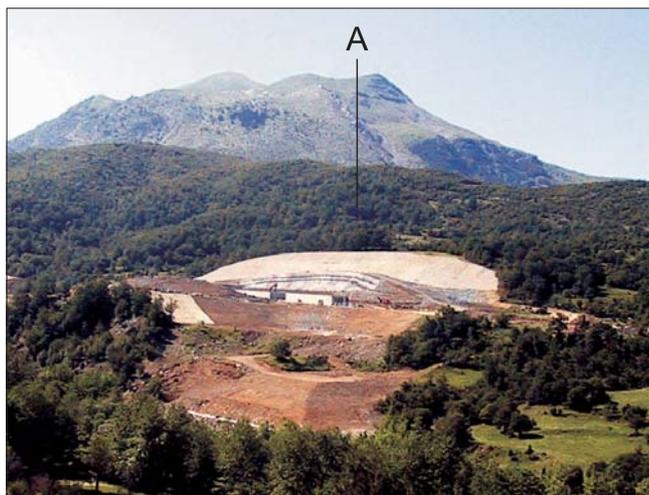
Fig. 2. Slope after TECCO installation

Failures were observed in the embankment fill, the weathered part of the flysch, and the deeper layers of the flysch. The failures can be separated into creeps and landslides. The largest part of the A area is an active deep landslide with a local creep. Creep causes instability at shallow depth (Figs. 2–4).

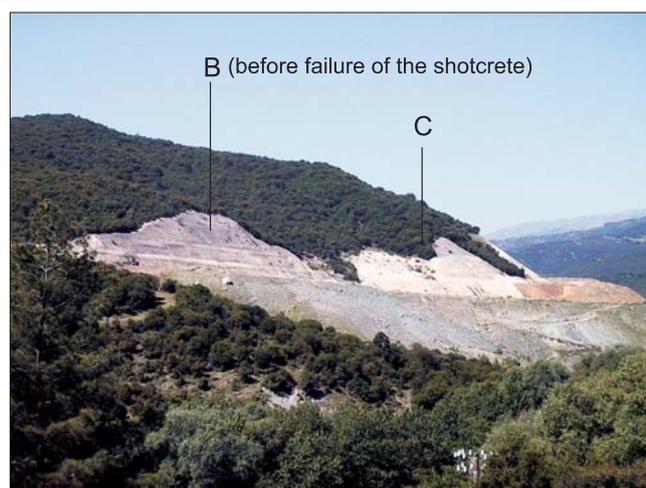
Fig. 3. Neighbouring shotcrete slopes

In general, the applied shotcrete was of poor quality. Evidently, the added fraction of cement was partially too poorly visible because of the darker shotcrete colour. In those areas, up to 20–25 mm of the top layer of the shotcrete facing is strongly weathered and mellowed with the resulted cracks. The appearing lighter areas were of better quality, less weathered and in better condition. Next to the bad quality of the shotcrete facing, the main problem was the erosion of the subsoil just beneath the shotcrete, due to insufficient or not adequate drainage measures. Locally, there were no more contacts between the subsoil surface and the shotcrete facing.

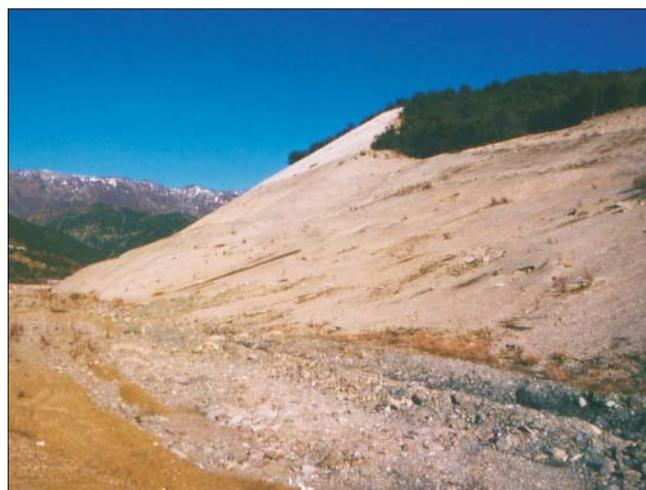
Fig. 4. Shotcrete facing at location D

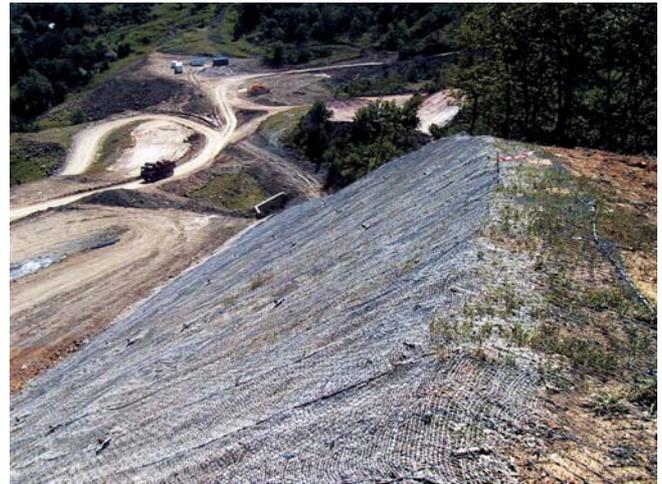
Fig. 8. After the mesh installation

erosion caused by heavy rainfalls, snow, water outflows or even wind (Figs. 8–10).

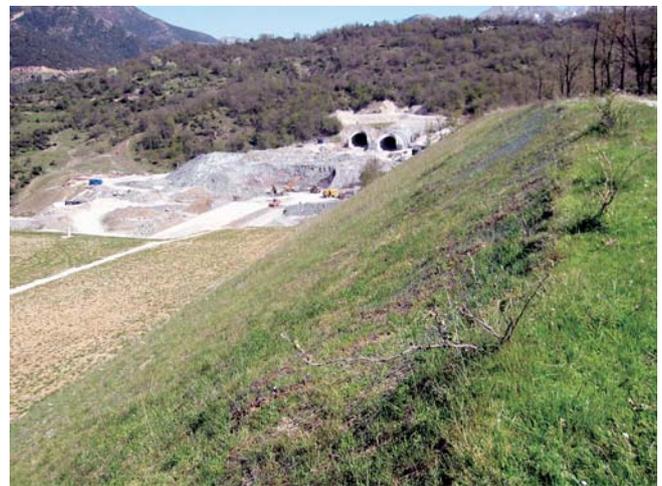
Fig. 9. After the mesh installation (one year later)

Two years from the installation during dry and hot summers and cold, wet winter weather, the slope is establishing a continuous vegetation cover by itself, even that it is built into the flysch consisting mainly of sand and siltstones. After an initial grass greening, the local vegetation was slowly creeping back onto the stabilised cut slope, with bushes and shrubs. No additional irrigation or reintroducing vegetation has been carried out during this period. The visual impact of the slope as described above is much more appealing com-

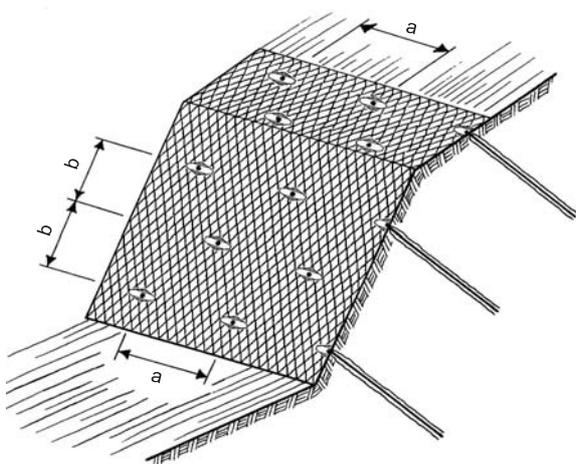
Fig. 7. General nail arrangement

The nailing was adapted to the static requirements based on the overall stability investigation considering sliding mechanisms with deeper-seated sliding surfaces. In addition, it is supposed to be checked if the flexible slope stabilisation system, consisting of the mesh cover and corresponding system spike plates in combination with the existing nailing, could withstand all stresses of the superficial instabilities. Based on the world-wide published and accepted RUVOLUM dimensioning concept, local instabilities between the single nails as well as superficial slope-parallel instabilities as shown on Figures 11 and 12 had to be investigated. Thereby, all proofs of bearing safety could be fulfilled.

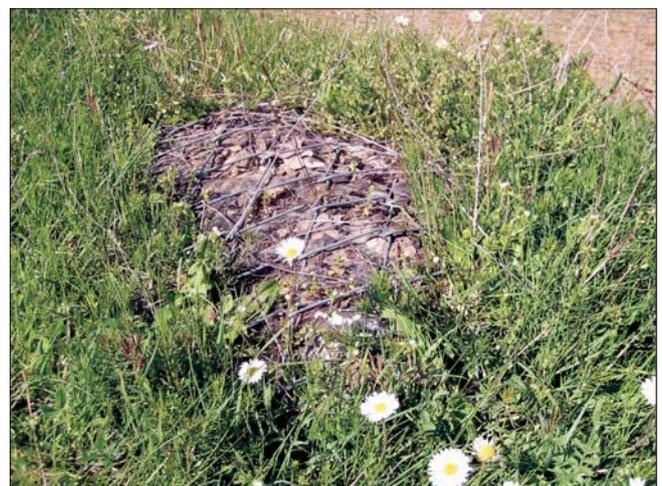
Fig. 10. A detail view of the mesh installation

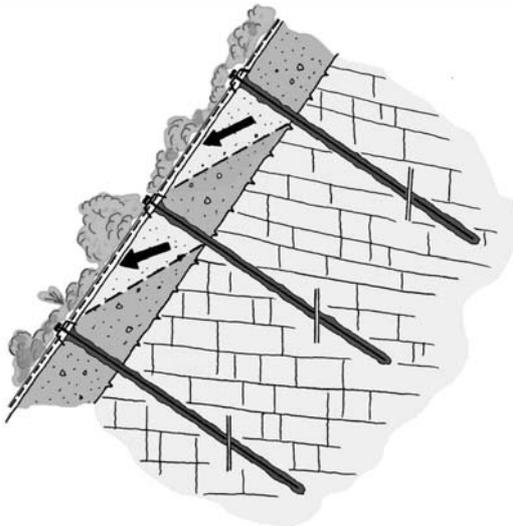
Fig. 11. Local instabilities between nails

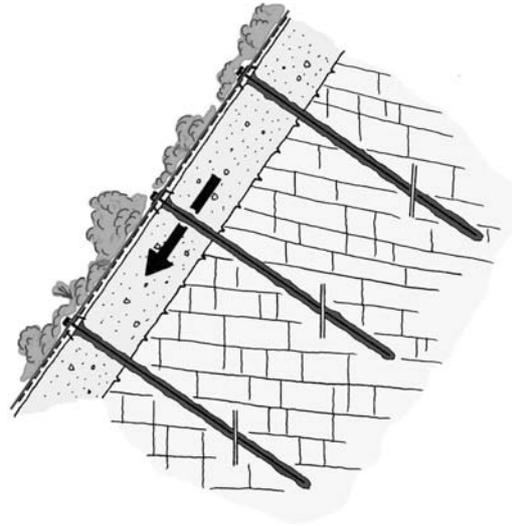
Fig. 12. Slope-parallel instabilities
