Geohazard assessment of the coastal zone – the case of the southern Baltic Sea

Uściłowicz, G., Szarafin, T., Pączek, U., Lidzbarski, M., Tarnawska, E., 2021. Geohazard assessment of the coastal zone – the case of the southern Baltic Sea. *Geological Quarterly*, 2021, 65: 5, doi: 10.7306/gq.1576

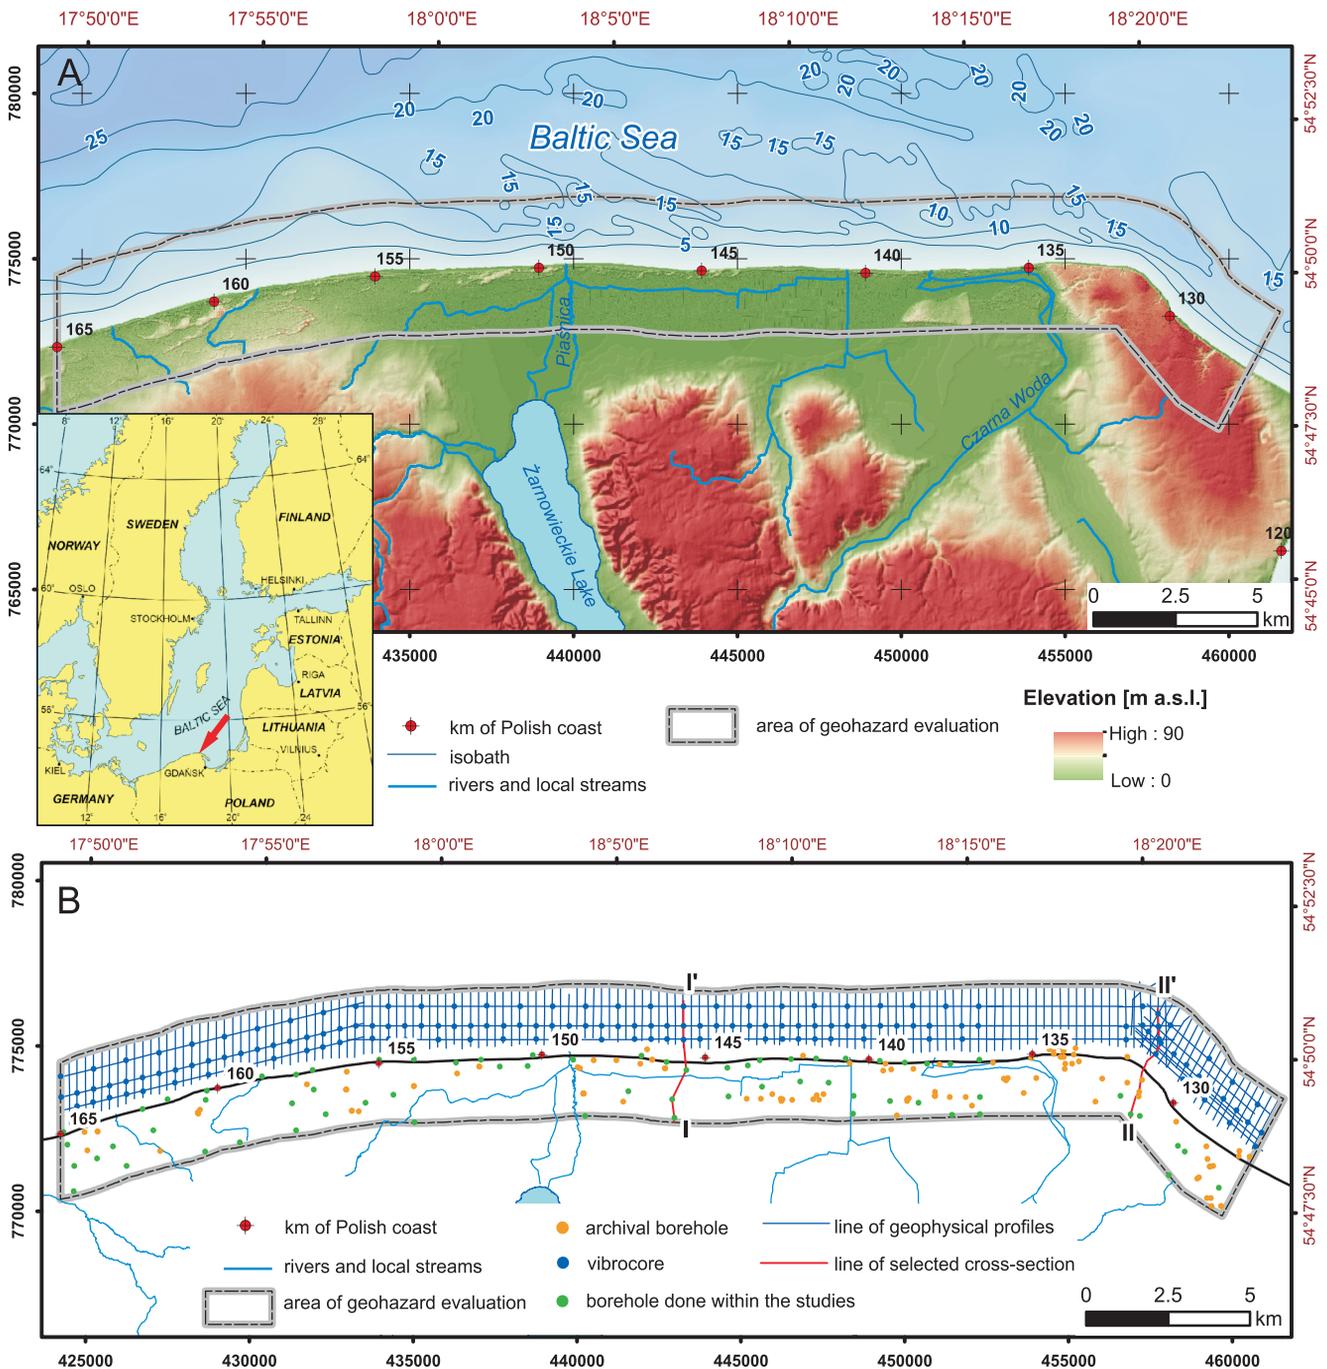
Fig. 1. Location of the study area (A) and map documenting the geological studies undertaken (B)

Source of bathymetry – Polish Geological Institute – National Research Institute, source of DTM's – Military Center of Geodesy and Remote Sensing and IT system of the Country's Protection Against Extreme Hazards (ISOK)

cliff (Fig. 1A). The beach width reaches several tens of metres and its profile varies depending on the season. The area is limited to the north by the sea, the seabed gradually deepening to the north or north-east to a depth of ~15 m, the isobaths being more or less parallel to the shore. There are two, sometimes three, sandbars close to the shore in depths of up to 5 m. Their elevation is between 1 and 4 m. To the south and east the area under discussion is limited by a morainic upland while the western part continues as a coastal lowland covered by dunes (Uścińowicz and Szarafin, 2018).

The varied methods used enabled identification of processes that may be considered as natural threats (Fig. 1B and Table 1).

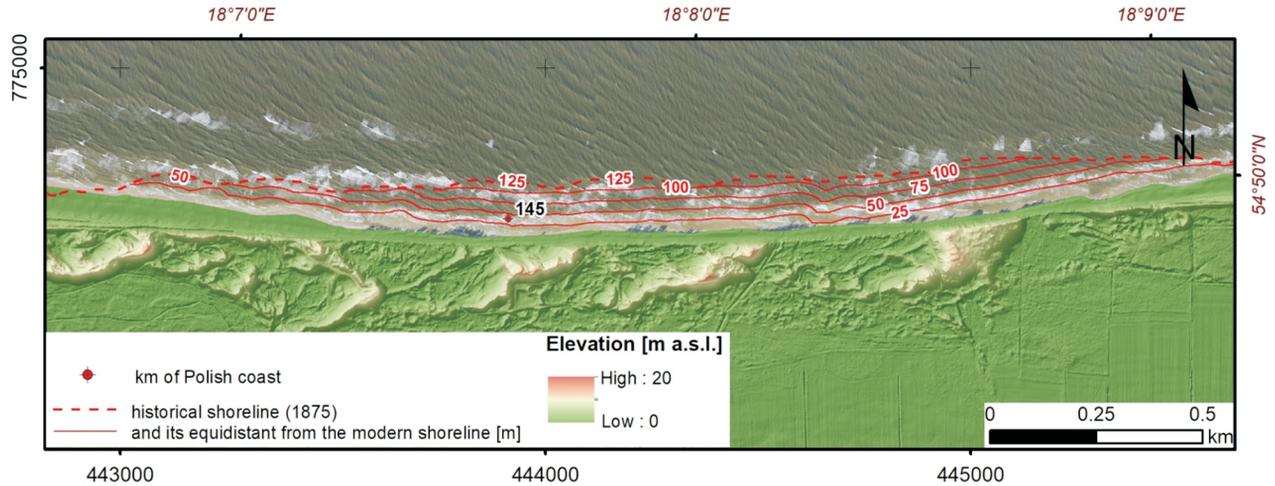
Fig. 6. Area of intense marine erosion (vicinity of the 145 km of Polish coastline)

Source of DTM – ISOK

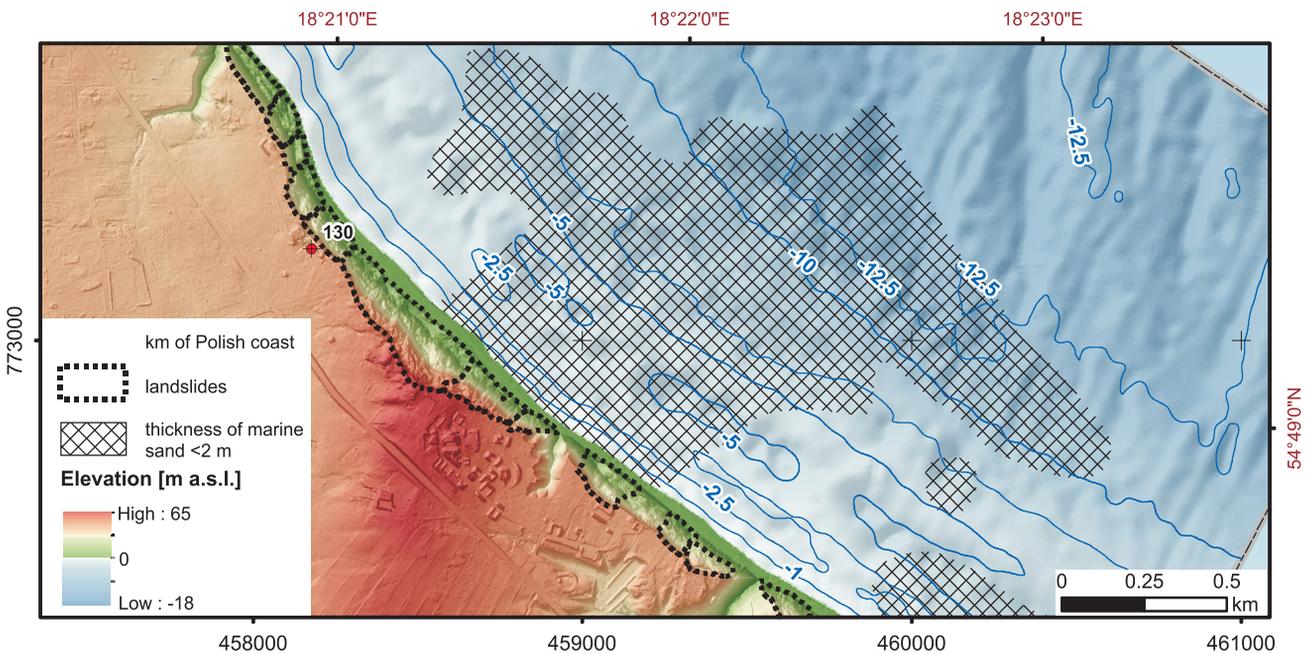
Fig. 7. Sand deficit in front of a set of complex landslides

Source of bathymetry – Polish Geological Institute – National Research Institute, source of DTM – ISOK

Deficit zones are places of increased erosion of the seabed and the adjacent coast. A good example of this situation is the region of Jastrzębia Góra and Karwia, where both the cliff section (Fig. 7) and the barrier is eroded. The barrier type coast is much more vulnerable to marine erosion than are cliffs, which is why the observed shoreline retreat is much larger and better visible there. This, in turn, creates pressure to use further forms of coastal protection that raises new problems (Fig. 8).

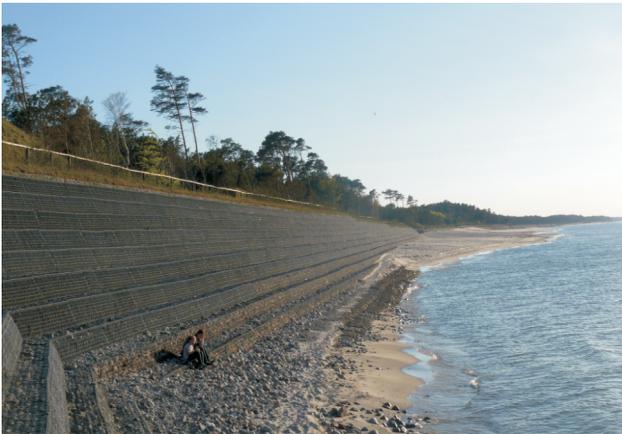
Fig. 8. Lack of beach in front of a seawall

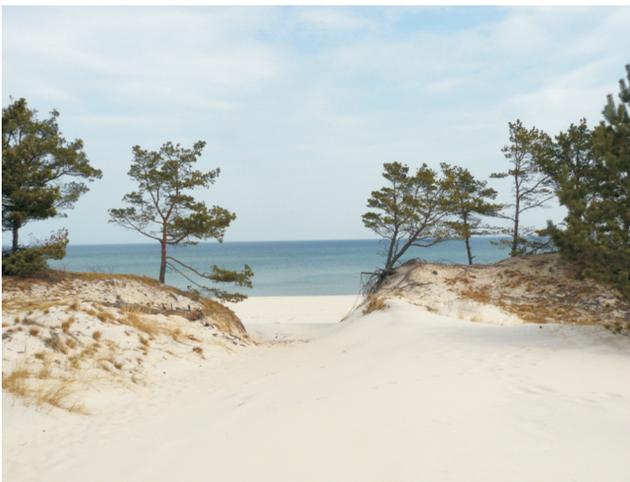
Fig. 9. Dune gap – a passageway for seawater

Photo taken on a barrier type coast (phot. G. Uścińowicz)
