Re-disposal of old exploitation wells – potential sources of environmental pollution in abandoned hydrocarbon deposits of the Czech Republic

Petr Bujok¹, Martin Klempa¹, Vladimír Slivka¹, Jakub Ryba¹,
Igor Němec², Věra Štátná², Michal Porzer¹

Abstract. This article deals with a significant issue of environmental protection of oil and gas deposits that have recently drawn a considerable attention. The presence of old insufficiently sealed or entirely unsealed wells, formerly serving a purpose of oil and natural gas extraction, pose a significant threat to the environment. In the South Moravia region of the Czech Republic (an area of hydrocarbon extraction both in historical and recent times), there is a significant amount (hundreds) of production wells. It is very difficult or often even impossible to find information in archival materials on the cease of extraction from these wells and on the system of abandonment procedures applied. During the recent surveying and re-abandonment works, it was found that many wells had been abandoned inadequately and unprofessionally, and numbers of wells still have not been abandoned at all. This poses a considerable risk to the South Moravian l

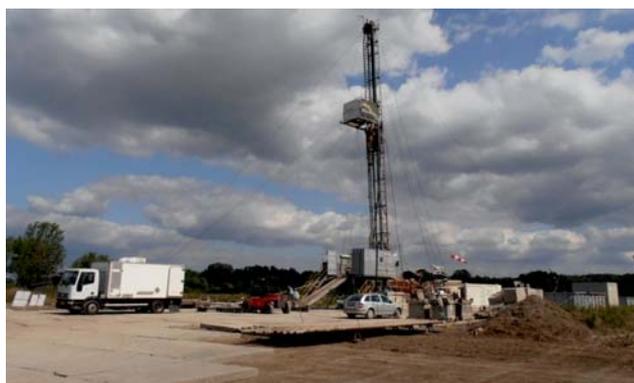
Fig. 7. Re-abandonment of the H-RIM70 well using the DIR 5505 drilling rig, Staré Pole near Nesyt (Propagační materiál PKÚ, 2014)

ded places on the casing and all the possible formations (Figs. 6A and 6B), which are potential sources of future contamination, in accordance with the logging measurements. The cement head is re-checked again and tested for being hermetically sealed by pressurization and de-pressurization. Finally, a cement bridge is made at the mouth of the well, casings are cut off under the surface and a steel lid is welded in place, on top of which a cement cap is made. The implementer's conditions for re-abandonment procedures make use of type BIR and DIR drilling rigs (Fig. 7 presents the DIR 5505 drilling rig).

The method of re-liquidation of the H 289 well in 2014 is shown in Figure 8B. The well was searched, kicked off, and equipped with a new head. It was further cleaned to a depth of 351 m (B5) using the DIR 5505 drilling rig (Fig. 7). Subsequently, part of the production casing cage

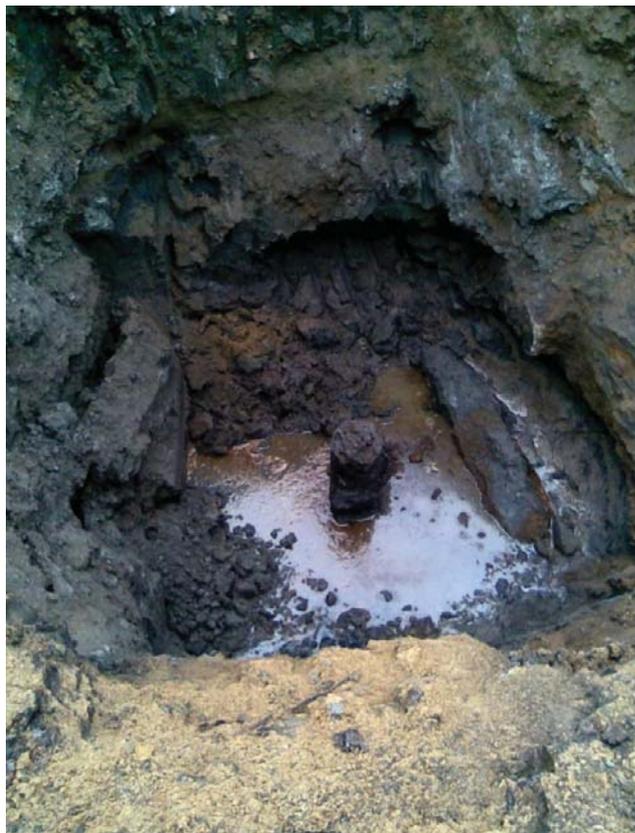
Fig. 10. Uncovered wellhead of the improperly abandonment HG21 well with spontaneous outflow of oil (Propagační materiál PKÚ, 2014)

dures. The wellheads were in some cases only shot off or torn off without subsequent isolation. The soil and groundwater sources in the area surrounding a substantial number of wells are consequently polluted. After uncovering the upper part of some of the wells, oil was found to be flowing spontaneously out through (or past) the casing remnants (Figs. 10 and 11).

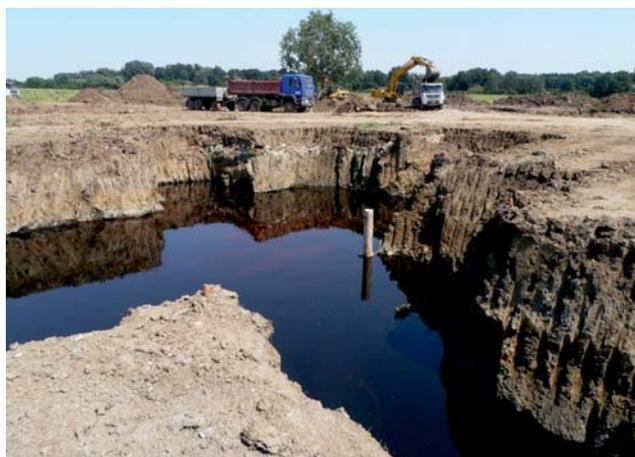
Fig. 11. An example of sanitation in the area surrounding the old re-abandoned wells. Contaminated soils are excavated, contaminated groundwater pumped away. Staré Pole u Nesytu (Propagační materiál PKÚ, 2014)

Based on a measurement of contamination extent in the areas surrounding the SEZ, the soils contaminated above the limit value are excavated and oil is pumped away from the groundwater surface (Figure 11). These soils are then transported to disposal sites and the removed oil is transported, along with the contaminated water, in large cisterns to decontamination stations (Propagační materiál PKÚ, 2014).
