Eocen numulitowy – z Tatr na ulice Poznania (patrz str. 476)

The Nummulitic Eocene: from the Tatra Mountains to the streets of Poznań (see p. 476)

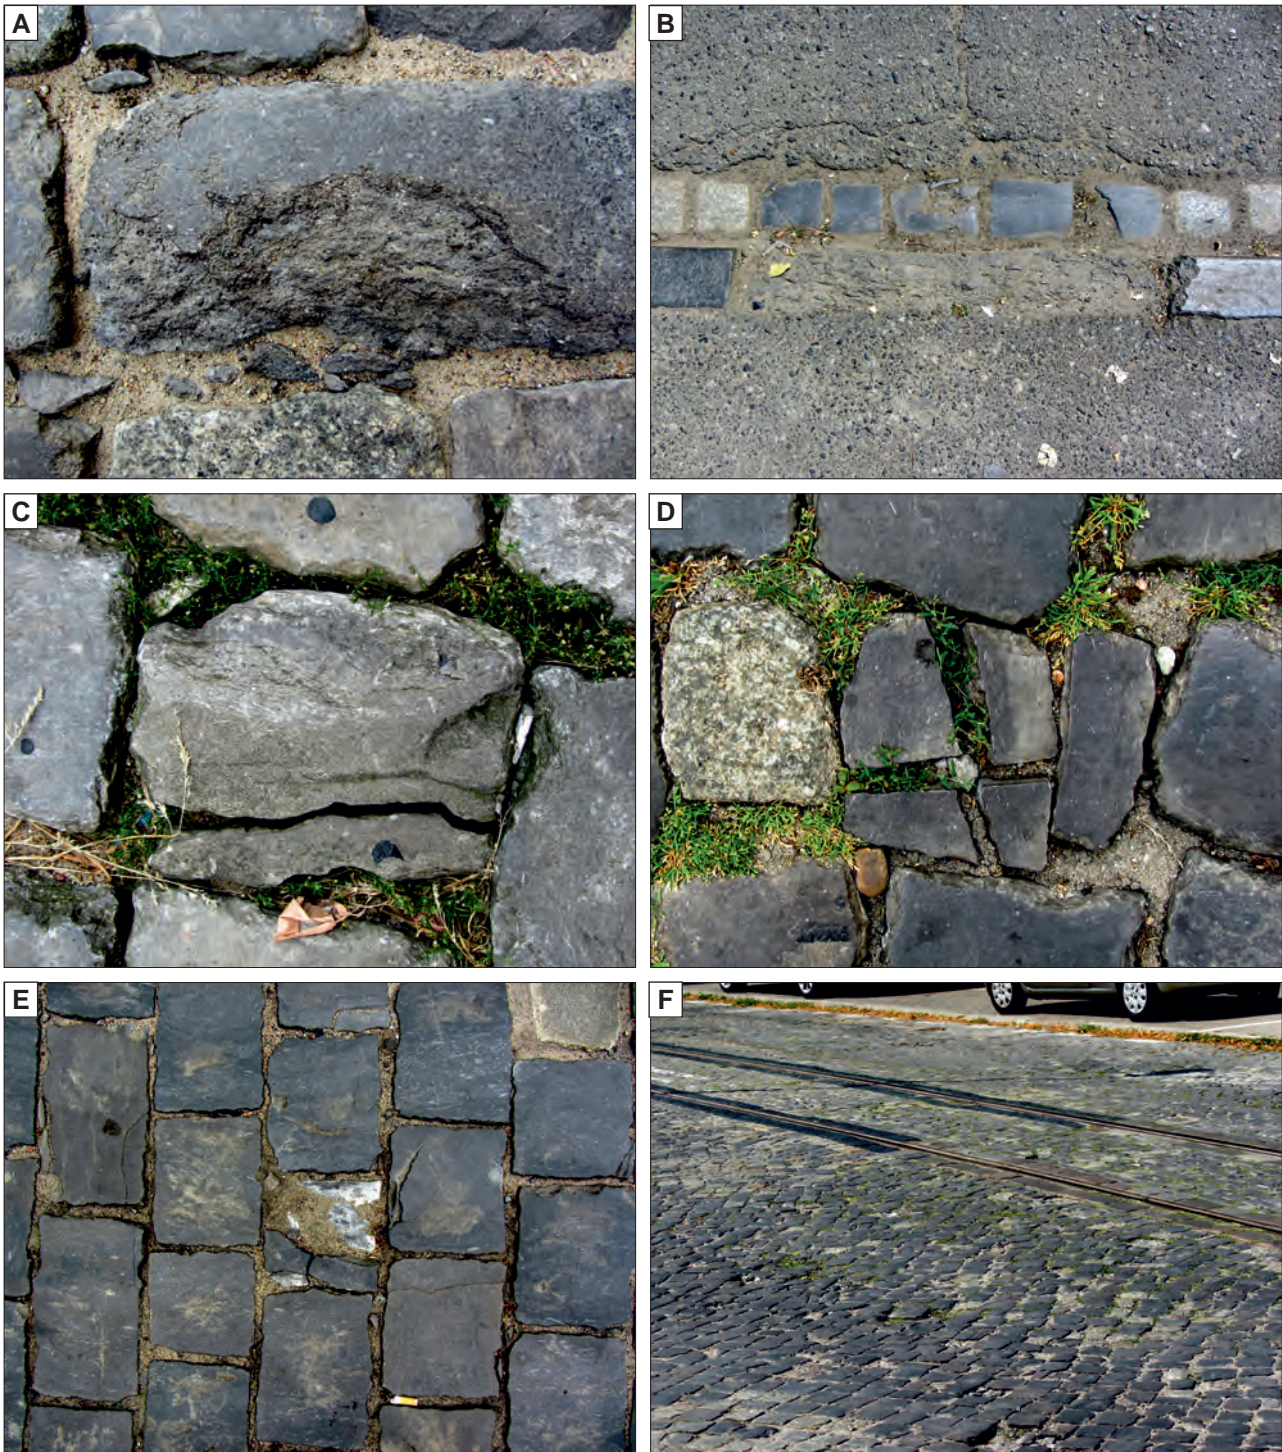
Ryc. 5. Przejawy degradacji nawierzchni wykonanych w Poznaniu z eocenu numulitowego: **A** – rozpadająca się kostka piaskowca o rozmiarach 35 × 20 cm, Stary Rynek; **B** – zniszczony krawężnik z piaskowca, sąsiadujący z nim element wykonany z mułowca jest dobrze zachowany, ul. 28 Czerwca 1956 r.; **C** – pęknięta kostka piaskowca, 12 × 9 cm, ul. Kozia; **D** – rozpadająca się kostka mułowca, 10 × 10 cm, ul. Zamkowa; **E** – odsłojenie na powierzchni kostki 15 × 15 cm, wzdłuż powierzchni żyły kalcytowej, ul. Romana Szymborskiego; **F** – zdegradowana jezdnia ul. Emilii Szymborskiej, z licznymi uzupełnieniami jasnym granitem strzegomskim

Fig. 5. Deterioration of surfaces paved with the Nummulitic Eocene: **A** – Stary Rynek, chipping stone block of size 35 × 20 cm; **B** – 28 Czerwca 1956 r. St., degraded sandstone curb with adjacent, well-preserved mudstone sett; **C** – Kozia St., cracked sandstone cube of size 12 × 9 cm; **D** – Zamkowa St., chipping 10 × 10 cm mudstone cube; **E** – Romana Szymborskiego St., delamination on the surface of 15 × 15 cm stone cube, along a calcite vein; **F** – Emilii Szymborskiej St., degraded carriageway with replacements made of light-coloured Strzegom granite
