## The development of unconsolidated sedimentary coastal cliffs (Pobrzeże Kaszubskie, Northern Poland)

Uścińowicz, G., Jurys, L., Szarafin, T., 2017. The development of unconsolidated sedimentary coastal cliffs (Pobrzeże Kaszubskie, Northern Poland). *Geological Quarterly*, **61** (2): 491–501, doi: 10.7306/gq.1351

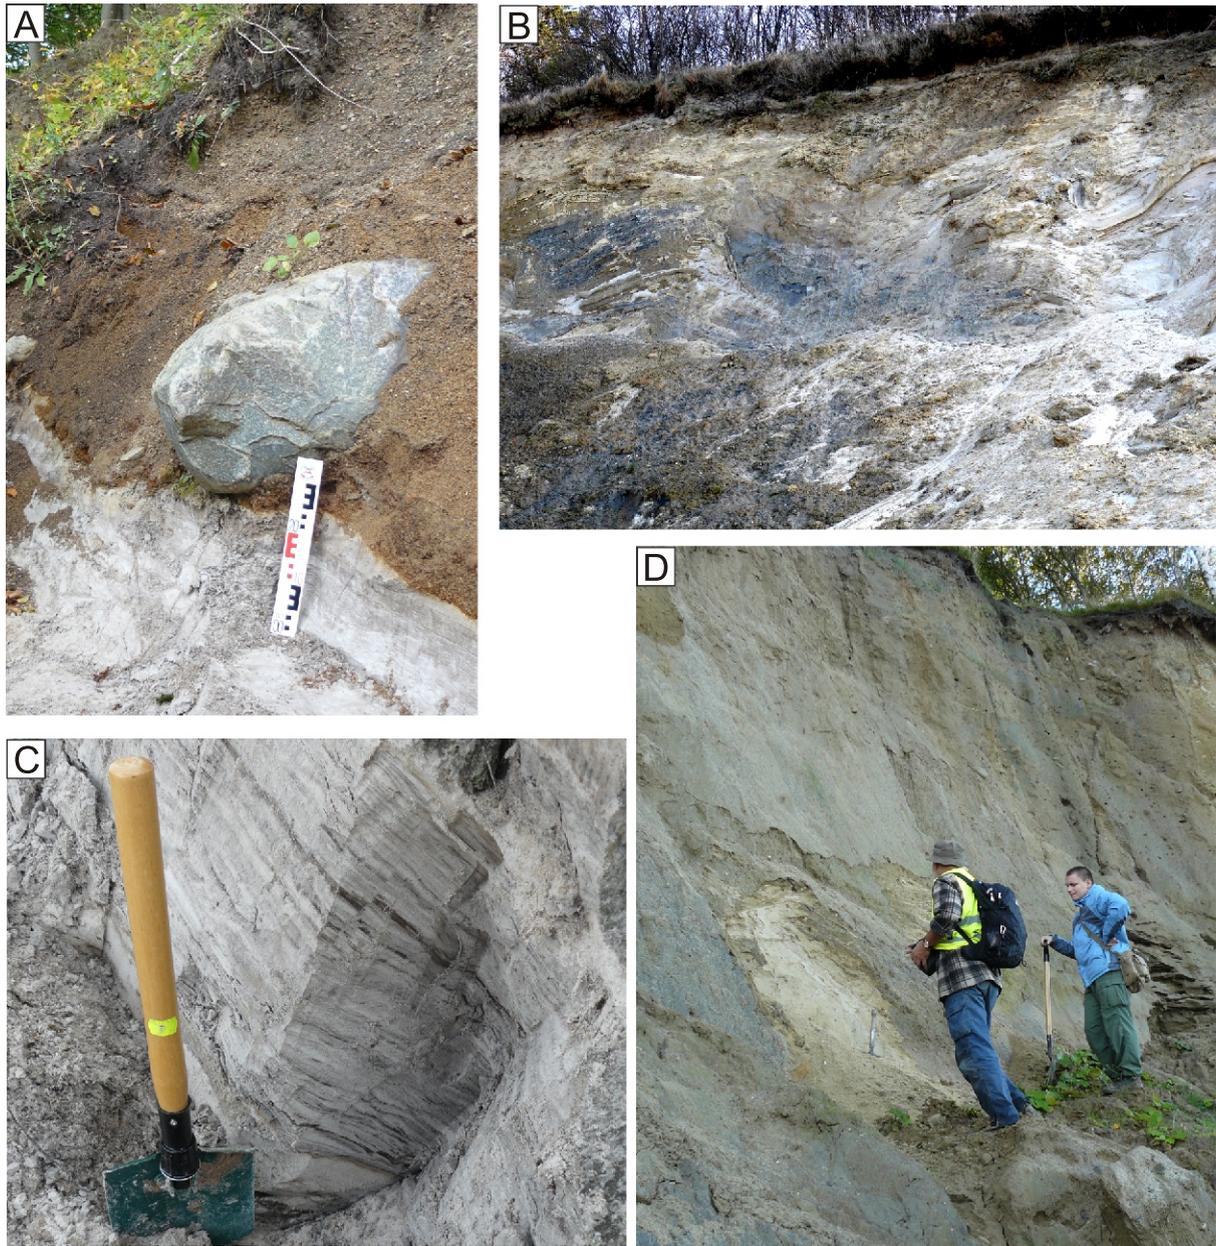
**Fig. 2. Photos illustrating some characteristic features of the study area**

**A** – Miocene (lower – light grey, silty sand)/Pleistocene (upper – sand with boulders) contact; **B** – deformed uppermost part of the cliff in the vicinity of Jastrzębia Góra; **C** – colluvium of the landslide (rotated complex of Miocene sand); **D** – Weichselian till succession (uppermost part of the cliff)

The oldest deposits cropping out in the upland are of Miocene age (Kramarska, 1999; Wagner, 2007). These are mainly silts, in places with lignite, and fine to medium grained sands. The top of the Miocene succession is variable and lies 17 m below sea level [b.s.l.] in the west. However, in the eastern and central part, it is exposed in the cliff face at ~15–17 m above sea level [a.s.l.]. The Miocene strata are overlain by Pleistocene deposits (Fig. 2).

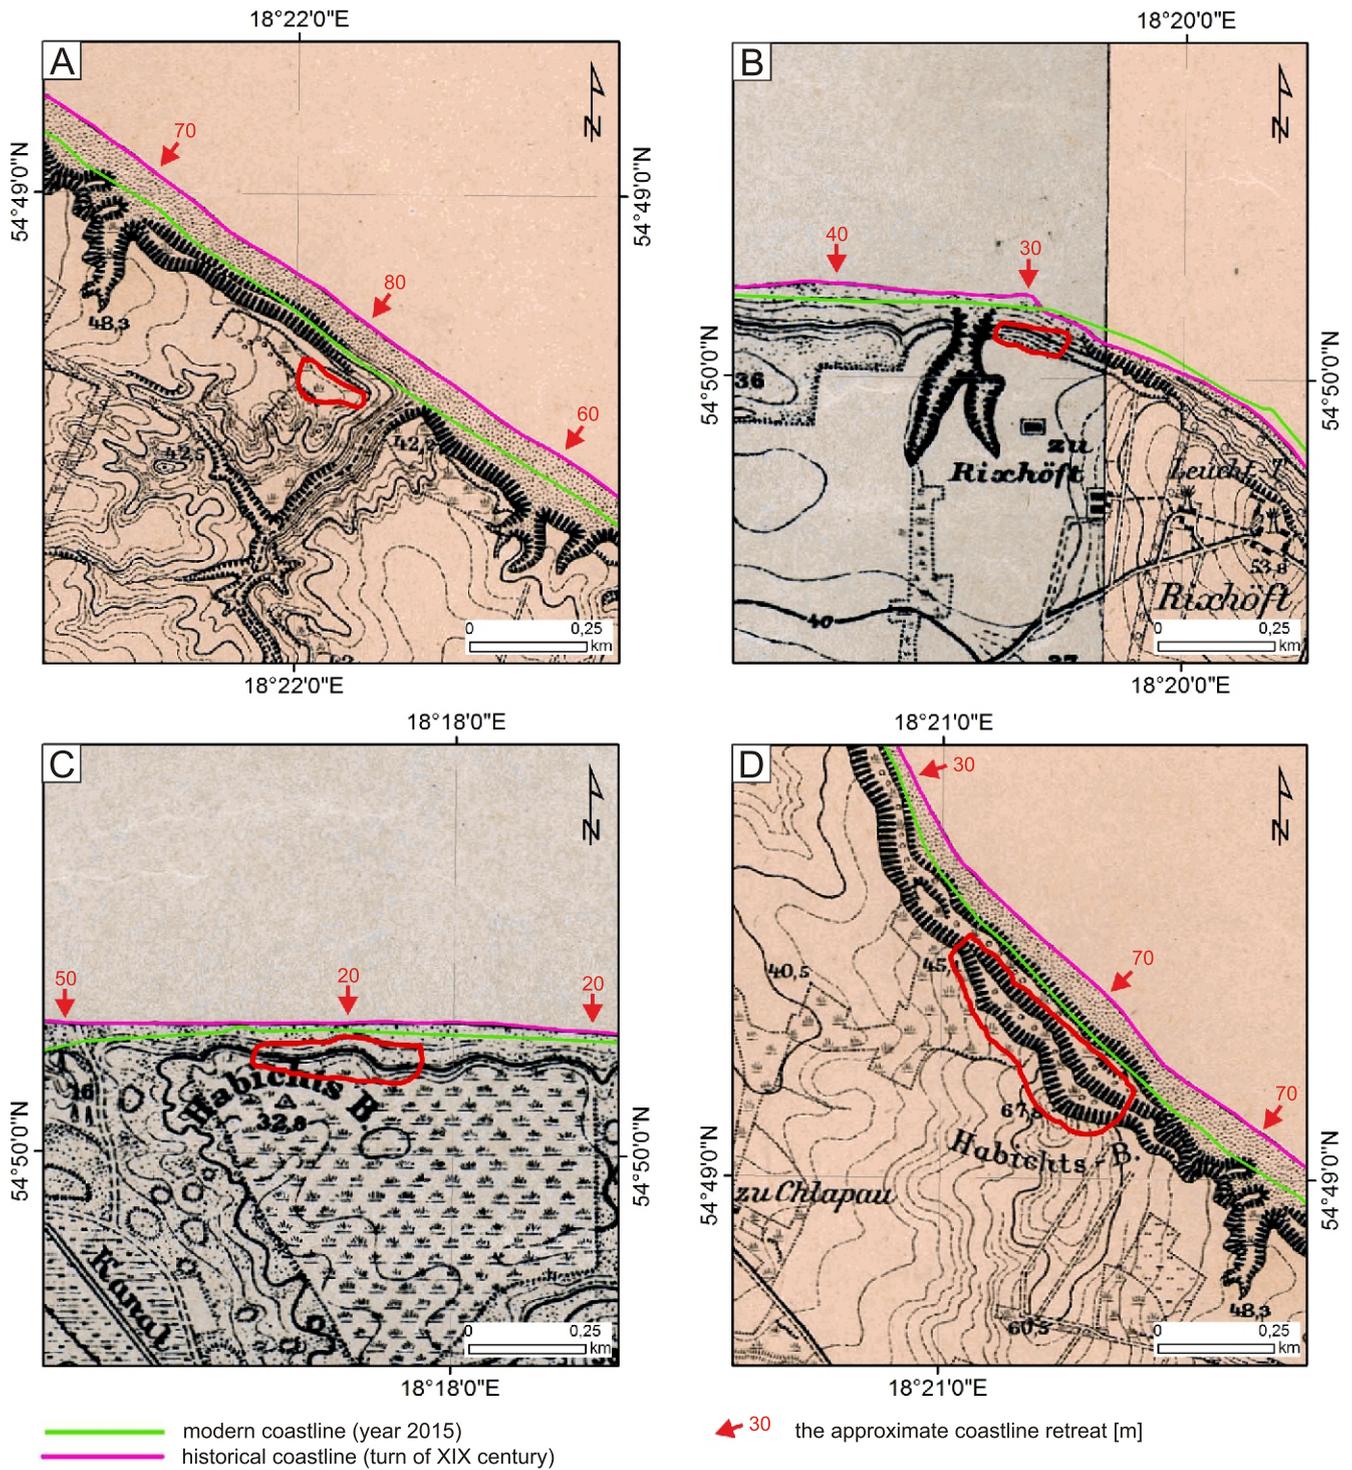
Fig. 3. Present boundaries of the landslides under discussion and position of the coastline (modern and historical) compared with historical topographic maps (Topographische Karte, 1877, 1910: 137-Ostrau; 138-Rixhof)

A – landslide 128.3–128.5 km “Rudnik”; B – landslide 131.9–132.1 km “Lisi Jar”; C – landslide 133.8–134.2 km “Jastrzębia Góra”; D – landslide 129.4–129.9 km “Pod Radarem”

Map analysis shows that the coastline in the vicinity of the landslide shifted landward by ~70 m in the west and 60 m in the east. The land retreat is ~80 m in front of the landslide. The landslide north-west of ravine Rudnik is not shown on archived maps. A topographic map from 1910 shows the characteristic steep, aligned slope (Fig. 3A). However, it is adjacent to the area covered by landslides, which may suggest that this is a part of an older mass movement enlarging its spatial range.

The coastline in the vicinity of the landslide shifted landwards by ~40 m in the western part and by 30 m at its the centre, at the front of the landslide. In its eastern part, the coastline has moved seawards by tens of metres as a result of coastal protection, via a raised seawall and beach nourishment.

The coastline in the vicinity of this landslide has shifted landwards by ~50 m in the west and by 20 m in the east. The land retreat in front of the landslide is ~20 m (Fig. 3C).

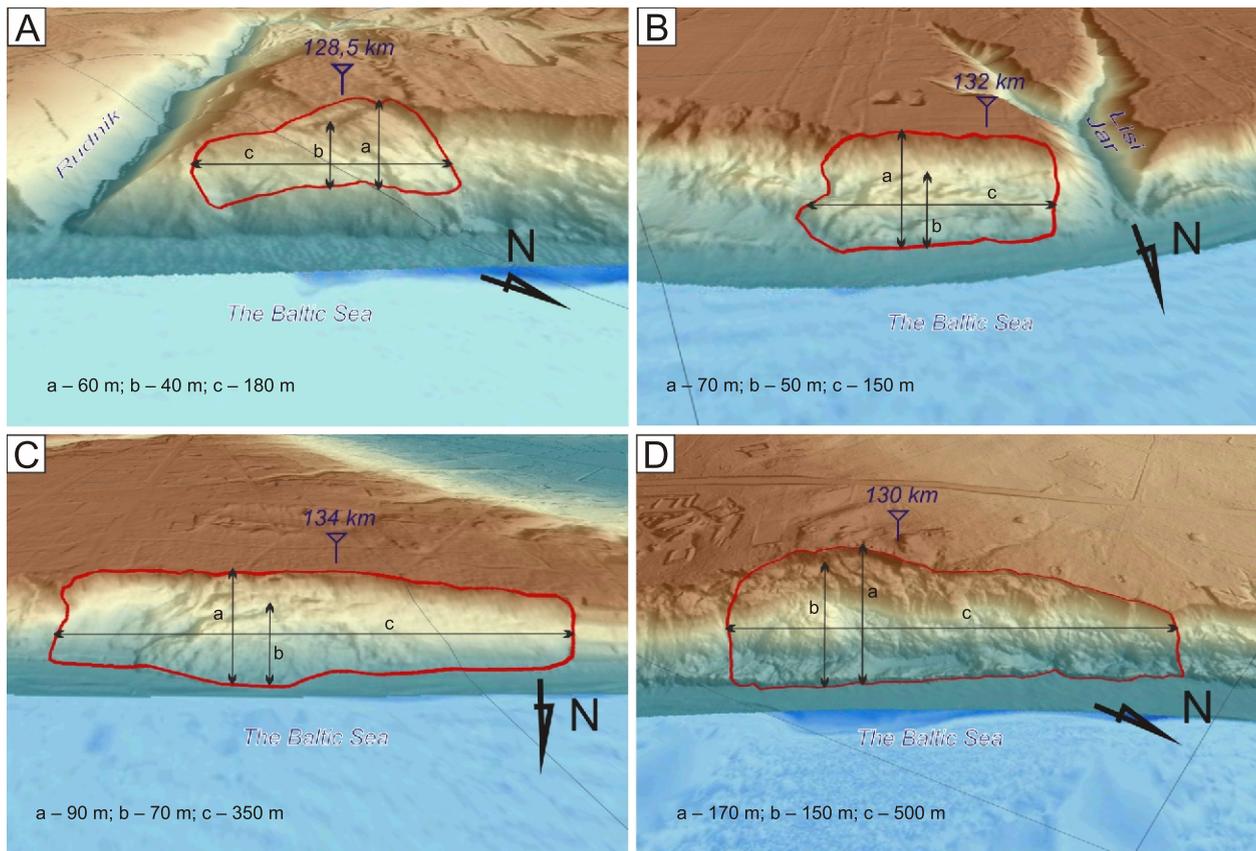
**Fig. 4. The digital elevation model (orthogonal view) and the basic parameters of landslides**

**A** – landslide 128.3–128.5 km “Rudnik”; **B** – landslide 131.9–132.1 km “Lisi Jar”; **C** – landslide 133.8–134.2 km “Jastrzębia Góra”; **D** – landslide 129.4–129.9 km “Pod Radarem”; a – total length, b – length of displaced mass, c – width of displaced mass

The cliff reaches a height of 42 m a.s.l. and the landslide extends over a distance of ~180 m. Its total length is ~60 m, while the length of displaced mass is 40 m. The main scarp of the landslide is 7 m high (Figs. 4 and 5). An interesting feature of this landslide is its incomplete development in comparison to the landslides discussed below. In particular, the landslide forms only the upper part of the cliff which is otherwise built of glaciofluvial deposits of Pleistocene age. The lower limit of the landslide (colluvium) reaches an elevation of ~20 m a.s.l. Directly below, the slope is built of silty-, fine- and medium-grained sands interbedded with Neogene silts and silty clays. However, there is some loose material at the cliff foot which cannot be regarded as a landslide deposits, having fallen from the adjacent cliff face.

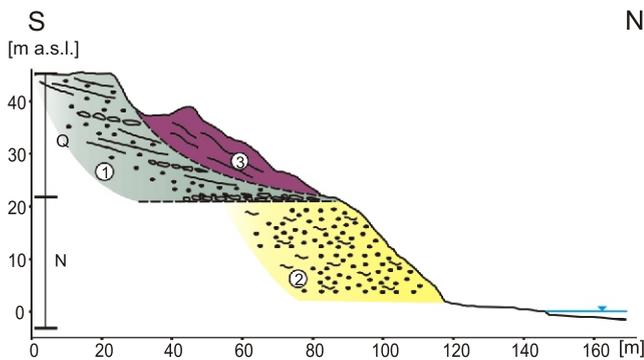
**Fig. 5. Illustration of the landslide 128.3–128.5 km “Rudnik”, geological cross-section**

1 – sand and gravel (with boulders in the lower part); 2 – sand interbedded with mud and clay; 3 – colluvium Q

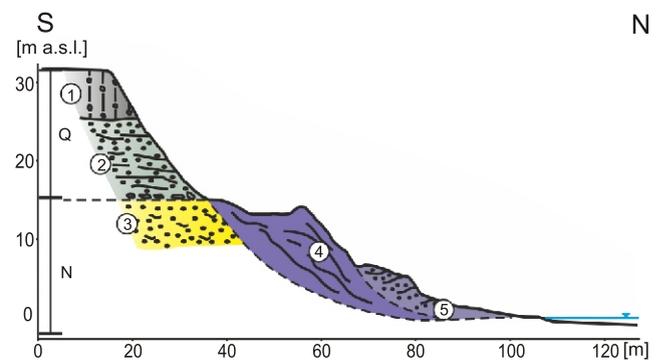
**Fig. 6. Illustration of the landslide 131.9–132.1 km “Lisi Jar”, geological cross-section**

1 – sandy till; 2 – fine and medium sand (with gravel in the lower part); 3 – fine and medium sand (with gravel in the lower part); 4 – colluvium Q+N; 5 – colluvium N

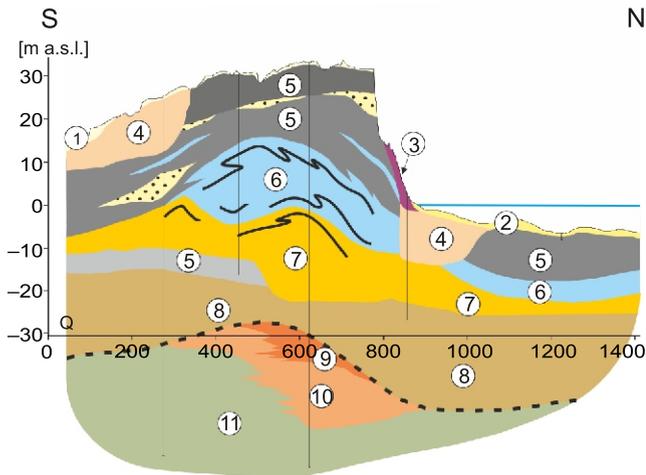
**Fig. 7. Illustration of the landslide 133.8–134.2 km "Jastrzębia Góra", geological cross-section**

1 – aeolian sand; 2 – marine sand; 3 – colluvium; 4 – fine sand (glaciofluvial); 5 – till; 6 – mud and clay (glaciotectonically deformed); 7 – sand and gravel (glaciofluvial?); 8 – sand (glacial); 9 – sand, mud, clay; 10 – sand and gravel; 11 – fine sand with glauconite

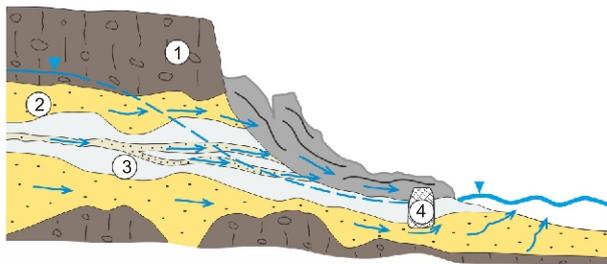
**Fig. 8. Simplified diagram of geological and hydrogeological conditions within the Jastrzębia Góra landslide**

1 – till; 2 – sand and gravel; 3 – mud and clay; 4 – seawall; arrows – direction of water flow

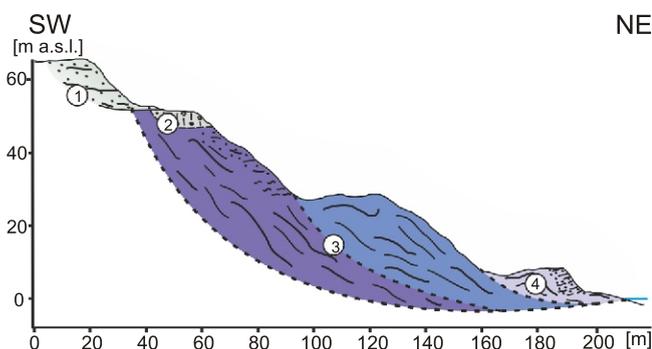
**Fig. 9. Diagram of the landslide 129.4–129.9 km "Pod Radarem", geological cross-section**

1 – sand; 2 – till; 3 – colluvium Q+N?; 4 – colluvium N

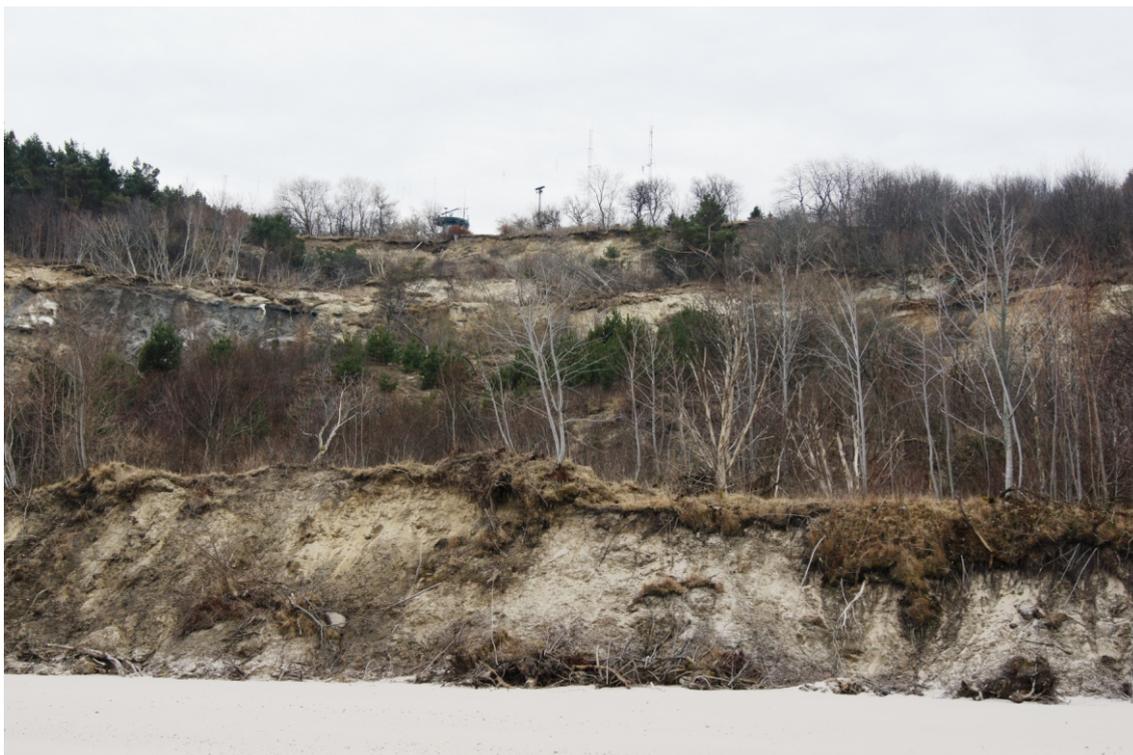
Fig. 10. Photo illustrating the “steps” within the landslide

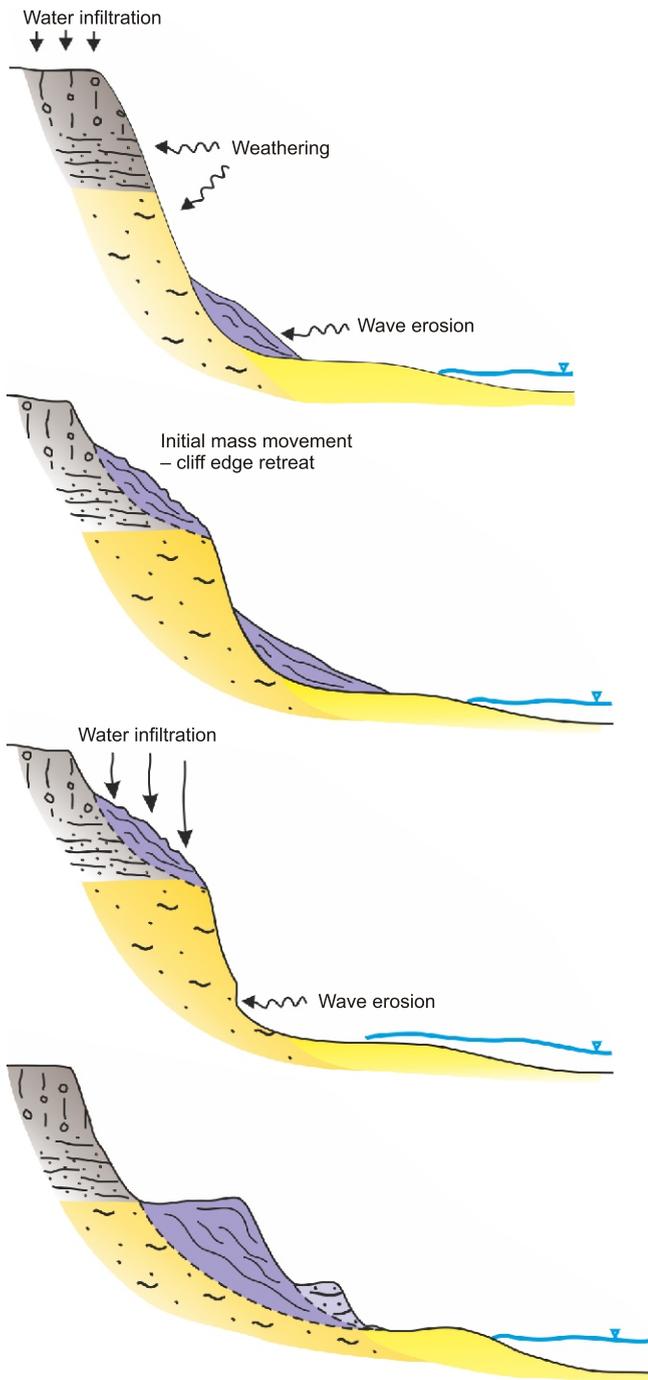
Fig. 11. The stages of development of simple landslides

The various landslides studied are at various stages of their evolution depending on their geological structure and morphology. In the case of the landslides from by the ravines of Rudnik and Lisi Jar (128.3–128.5 km; 131.9–132.1 km) there occur the same processes but at different stages of development. The starting point for this type of landslide is a relatively stable cliff, where gravitational movements may occur, but without substantial evidence indicating the existence of earlier mass movements. In such conditions the initial movement starts at the cliff top (built of Pleistocene deposits) and reaches the boundary of the Pleistocene/Neogene deposits. It affects poorly lithified deposits, but without affecting underlying, Neogene strata (vide the Rudnik landslide). The Neogene deposits are more cohesive than the Pleistocene ones, so their vulnerability to sliding and water infiltration are lesser. Such state is especially visible during increased storm surge periods when the lower parts of cliff become nearly vertical. Next, increased infiltration of rain-water into the initial colluvium and underlying rocks of the Miocene age may occur. These rocks are characterized by a higher level of diagenesis than the Pleistocene deposits. Such conditions combined with marine erosion destabilize the foot of the cliff and lead to the development of the landslide proper that covers the whole slope (Fig. 11).

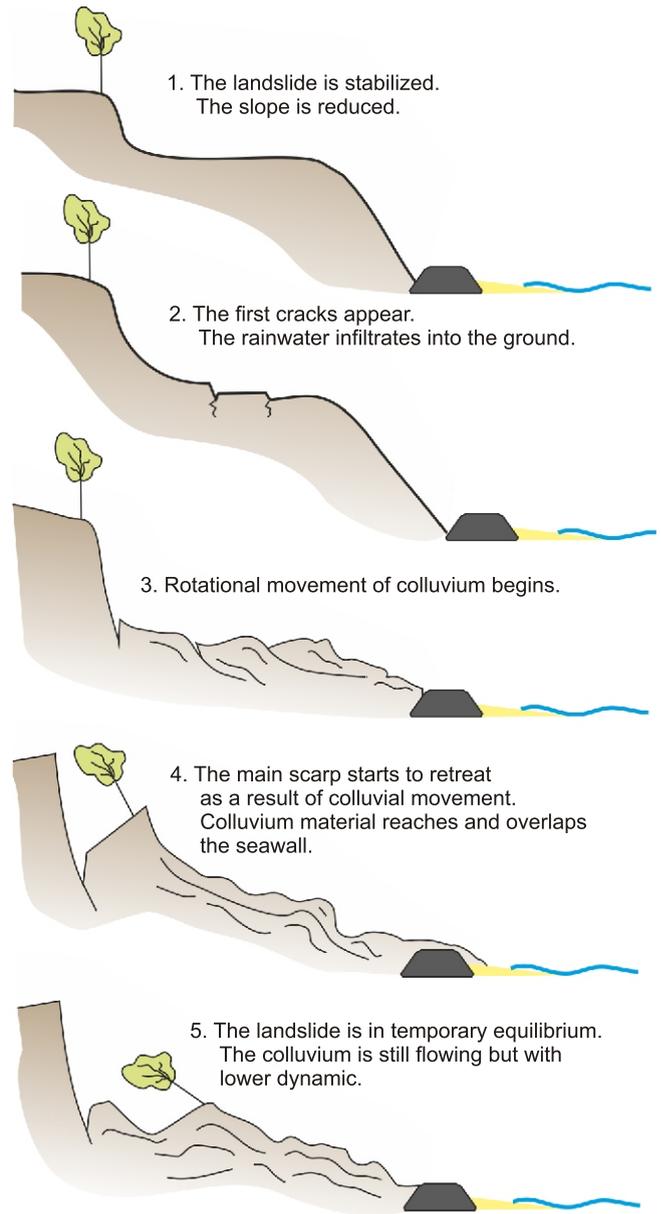
Fig. 12. The stages of development of the Jastrzębia Góra complex landslide
