## Post-mining deformations in the area affected by the former “Siersza” Hard Coal Mine in Trzebinia (southern Poland)

Over the recent years, post-mining terrain deformations has been increasingly frequent around Trzebinia. Sinkholes appearing increasingly close to buildings have become a significant geohazard. We show that post-mining deformations in the area is much more extensive than previously estimated. Identification of the deformations involved analysis of historical aerial photographs, airborne laser scanning data, orthophotomaps and satellite radar data. Moreover, laser scanning of selected areas using an unmanned aerial vehicle and a terrestrial laser scanner was carried out together with field mapping. In the study area, 527 sinkholes and 254 linear-type deformation structures were identified. Comprehensive mapping of sinkholes – including those previously unknown, located outside built-up areas – showed that areas where sinkholes had been remediated in the past were also at significant risk. A number of sinkholes are also located outside areas of shallow (up to 100 m below ground level) mining. The use of satellite radar interferometry showed that continuous deformati

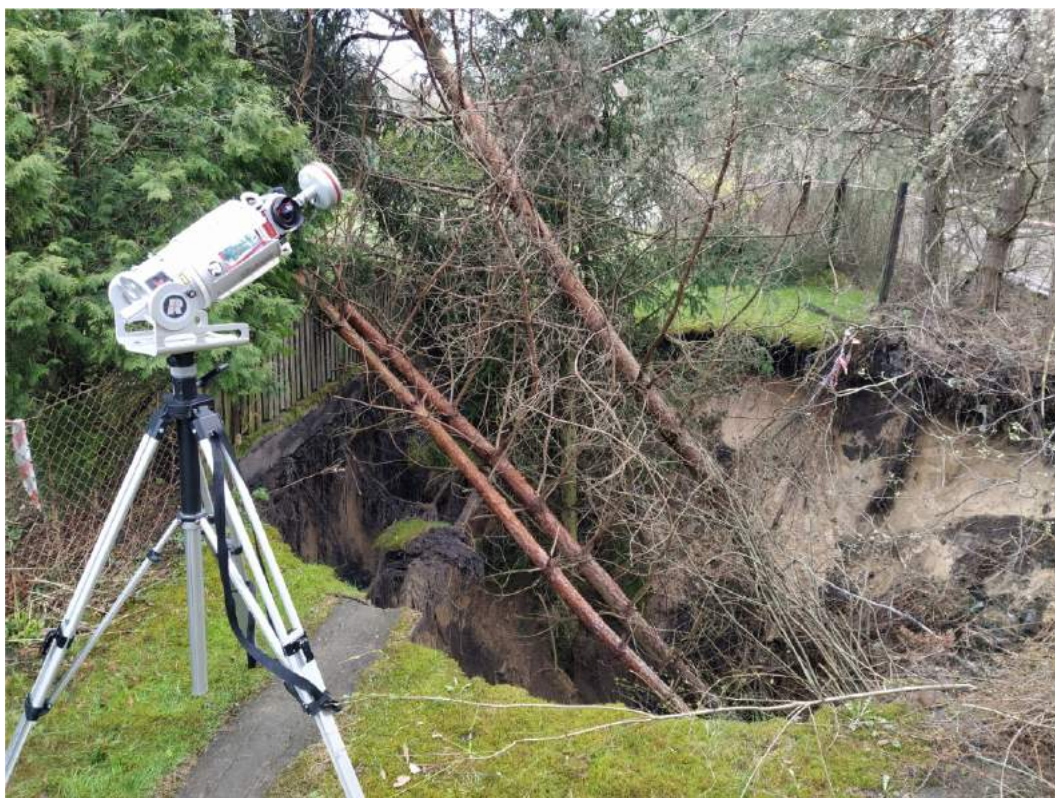
Fig. 5. TLS of a sinkhole near the allotment gardens
