## The complex hydrogeology of the unique Wieliczka salt mine

**Keywords:** rock salt, hydrogeology, water catastrophes, Wieliczka Salt Mine

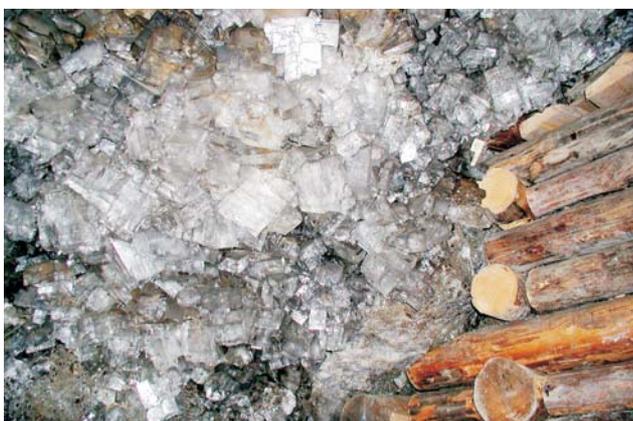
Fig. 1. Crystals cover fragment of the Lower Crystal Cave. Photo by J. Przybyło

capacity of 1000 m<sup>3</sup> and 706 m<sup>3</sup> respectively, where walls and roofs are covered with natural salt crystals, often having their ideal shape (Fig. 1). The Crystal Caves were discovered at the end of the 19th century during salt mining in the eastern fringes of the mine. Due to high protection offered to natural formations of salt crystals, visiting the site is very restricted (Brudnik et al., 2000).

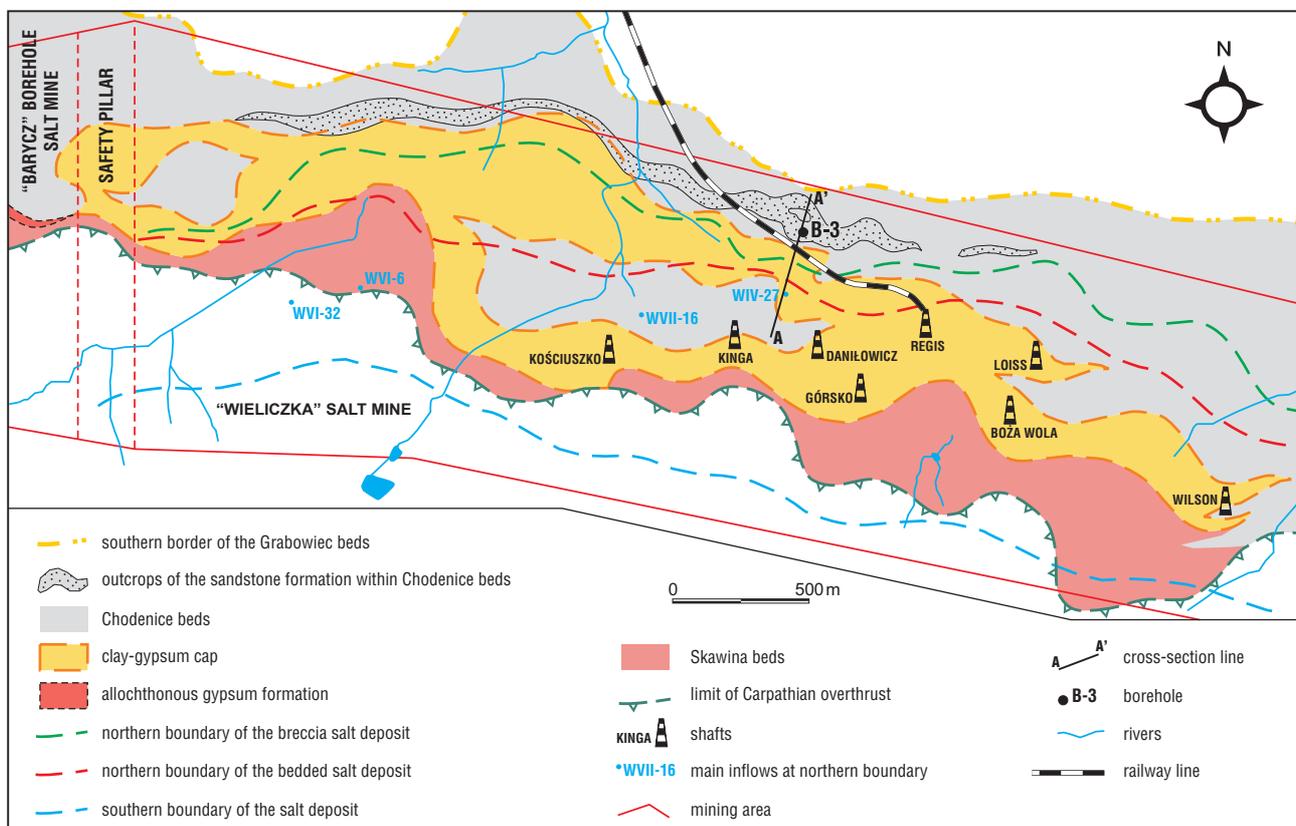
Fig. 2. Geological map of the Wieliczka salt mine

The Wieliczka bed runs in the direction from West to East and extends for some 10 km, and its width in the vicinity of Wieliczka town is some 1.2 km. The bed lies in an area of a complicated geological structure. The most important in this regard are the Carpathian flysch deposits that are densely folded and shifted towards the north (Fig. 2).

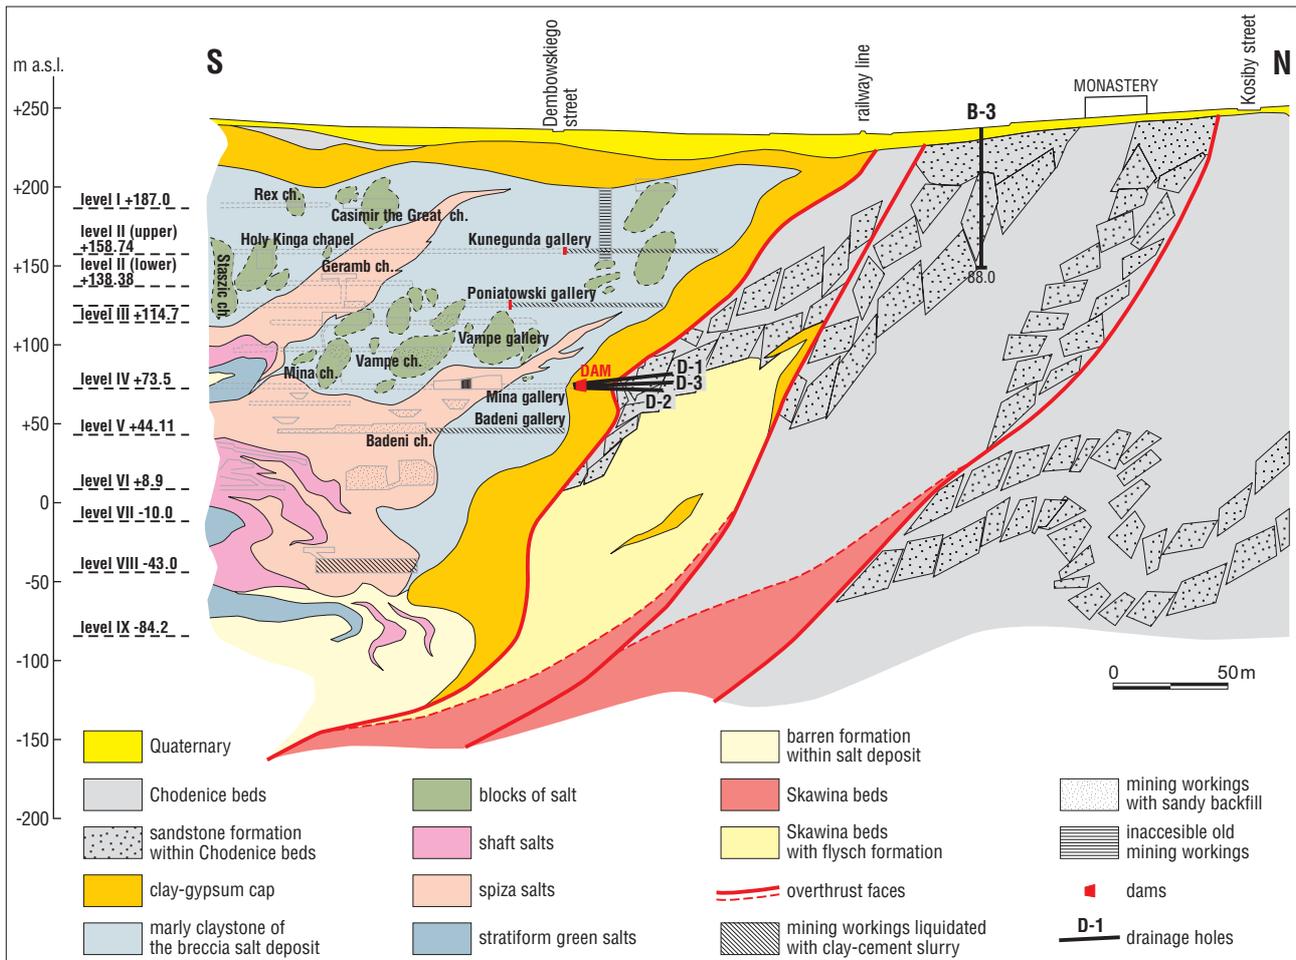
Fig. 3. Geological cross-section at the northern edge of the Wieliczka salt mine

large sizes and volumes reaching 100 000 m<sup>3</sup> were dug out from the inside and at present their remnants form chambers located at upper levels of the mine. Parts of them are included in the tourist route throughout the Wieliczka Salt Mine (Fig. 3).

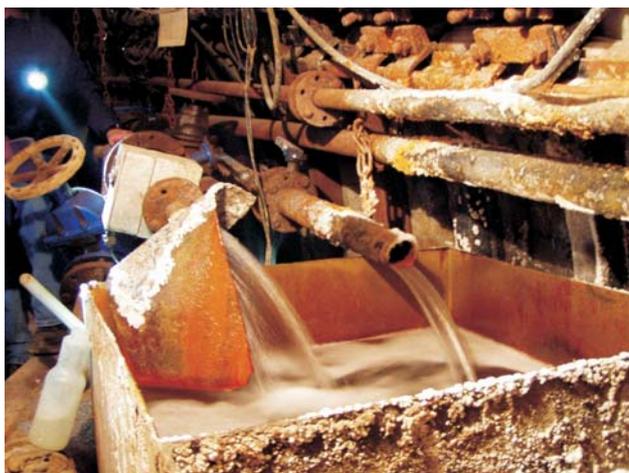
Fig. 4. Two main water inflows in the Wieliczka Salt Mine (from the left) WVII-16 and WVI-32. Photo by J. Motyka

The next event of a sudden groundwater inflow into the mine occurred in 1959, in the Kosocice crosscut, which is located at the 5th and the 6th levels. Inflow of fresh, unsaturated groundwater at a rate of 60 m<sup>3</sup>/h (1000 l/min) appeared from an old borehole that was left open. The leak was plugged and head pressures were recorded at the plug with a maximum value reaching 20–25 atm. In the following year, inflow of unsaturated brines with mineralisation of 190 g/dm<sup>3</sup> was recorded at Schmidt crosscut. Discharge of groundwater inflow that was created due to a subsidence of Schmidt adit ranged from 0.04 to 3.5 m<sup>3</sup>/h (0.7–60 l/min). As in the case of Kosocice crosscut, groundwater inflow at Schmidt crosscut was plugged and hydrostatic pressure recorded at the dam reached 7 atm over the past few years. Large groundwater inflow into the Wieliczka salt mine occurred in 1966. As a result of the uncontrolled development of Z-32 chamber, located at V/VI level, inflow of unsaturated groundwater from outside the salt formation occurred. The leak of an initial salt content of 140 g/dm<sup>3</sup> NaCl and groundwater flow rate at some 3.6 m<sup>3</sup>/h (60 l/min) was captured outside the salt bed, underneath the Z-32 chamber. This groundwater seepage still exists and is monitored by an internal groundwater monitoring network of the mine (point no. WVI-32; Fig. 4).

The next episode of large groundwater inflow into the mine happened in 1972. Groundwater inflow occurred in a chamber known as Fornalska II and had relatively low salt content of ca. 70 g/dm<sup>3</sup> NaCl and a flow rate of 9–20 m<sup>3</sup>/h (150–330 l/min). The seepage area was secured by destroying adjacent chambers and creating a dam that closed the Fornalska II chamber. The leak was later enclosed using a tubing casing which still exists as a monitoring point WVII-16 (Fig. 4).

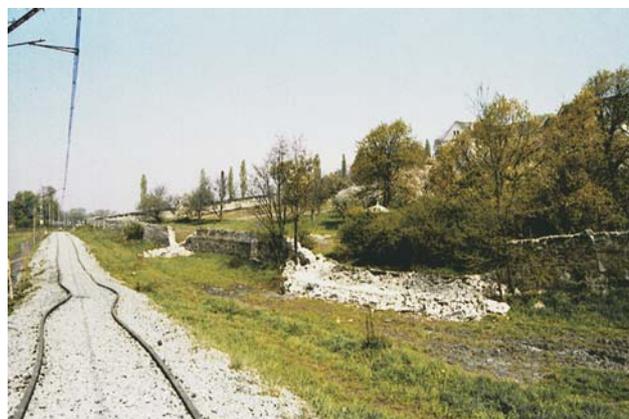
Fig. 5. Beginning of the subsiding trough formation on the outskirts of Mina crosscut. Photo by J. Przybyło

The most dangerous groundwater leak to the mine in its recent history happened on 13th April 1992. In Mina crosscut, at the 4th level, a groundwater inflow of unsaturated brine with a high content of silt and sands occurred with a rate of 12 m<sup>3</sup>/h (200 l/min). A small leak with the flow rate of a few l/min was known in this location before and was created in 1911–1913 by puncturing an isolating layer between the salt bed and adjacent saturated sandstones while extracting the salt bed from Mina chamber. In the early 90s, as part of a project that aimed to liquidate a num-

ber of groundwater leaks into the Wieliczka Salt Mine, a decision was made to stop the groundwater inflow into the Mina crosscut. The groundwater inflow into that pit, which happened in April 1992, was associated with reconstruction works at the end of the crosscut before the final closure of the inflow (Garlicki & Wilk, 1993). Many attempts to cease the leak resulted in increasing flow rates, and each time, the groundwater leakage was rich in sediments and had the consistency of a pulp. The mass loss that was being created within the mine as a result of soil transfer into the mine resulted in deformations of ground surface. North of Mina crosscut, a large subsidence trough was created, which covered an area between the mine and the Monastery of Franciscan Fathers. The centre of the basin occurred at a railway line linking Wieliczka with Cracow causing damage to its trackways. Specifically large land deformations occurred at the monastery grounds, where walls surrounding the monastery were damaged and cracks with a depth of 2–3 metres occurred in the hill on which the monastery stands (Fig. 5). The failure of Mina crosscut caused numerous cracks and crevices in the monastery's walls, whose stability was greatly endangered in light of the further development of the subsidence trough. To remedy the situation, two-component polyurethane resin was injected into the trough

using boreholes drilled in the vicinity of the scouring basin. A waterproof dam was also built in Mina crosscut, within the gypsum-clay layer surrounding the salt bed. To do so, groundwater inflow into Mina crosscut had to be taken away and this was achieved by pumping water out via boreholes drilled from the ground surface (drainage line R). Three horizontal drainage boreholes were drilled (drainage line D), which drained water seeping from outside the salt bed, directly from Chodenice sandstones. After finishing building the dam, the total groundwater discharge from drainage boreholes accounted for some 7.2 m<sup>3</sup>/h (120 l/min). Within the groundwater monitoring network of the Wieliczka mine, this inflow was named as WIV-27. For the subsequent 15 years after the Mina crosscut accident, a programme of measures was carried out in the mine that aimed at tightening and reinforcing the pit in the vicinity of the dam by injecting a mortar of cement and silt. Between May and October 2007, drainage pipes in Mina crosscut were either liquidated or plugged and groundwater inflow into the pit was successfully stopped.

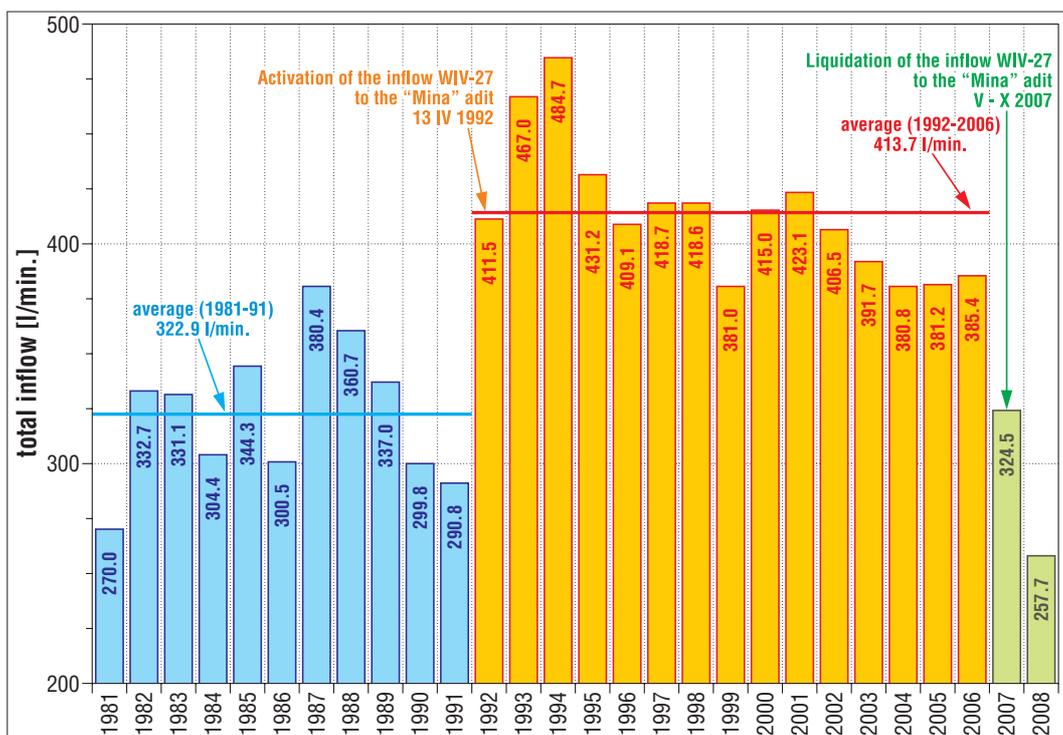
Fig. 6. Groundwater inflow to the Wieliczka salt mine during the period of 1981–2008

Groundwater inflow into the Wieliczka Mine had increased with time in parallel to subsequent water accidents described above. Escalation of these cases occurred after the 1960s and carried on until the catastrophe in Mina crosscut in 1992. It was at the beginning of the 1990s, when groundwater inflow volumes into the mine reached their maximum level, which in 1994 was estimated at 29.1 m<sup>3</sup>/h (ca. 485 l/min). Over the subsequent years, the inflow stabilised at a little below 24 m<sup>3</sup>/h (400 l/min) (Fig. 6).

Liquidation of the inflow at Mina crosscut, which just before its closure was some 7.2 m<sup>3</sup>/h (120 l/min), led to sharp decline in the total groundwater inflow volume into the mine, to a volume equivalent to that from before the catastrophe.

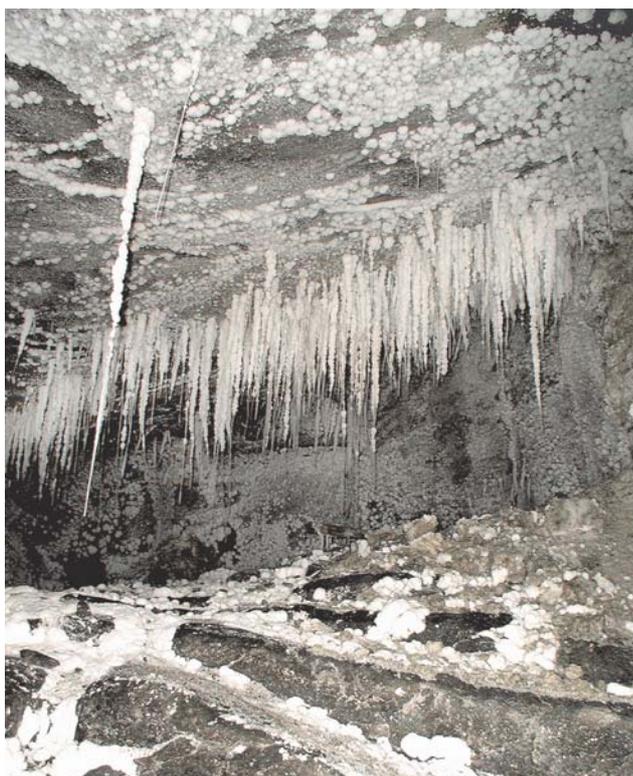
**Fig. 7.** Artificial dripstones in a Ferro chamber in the vicinity of the inflow WIIIn-19. Photo by J. Przybyło

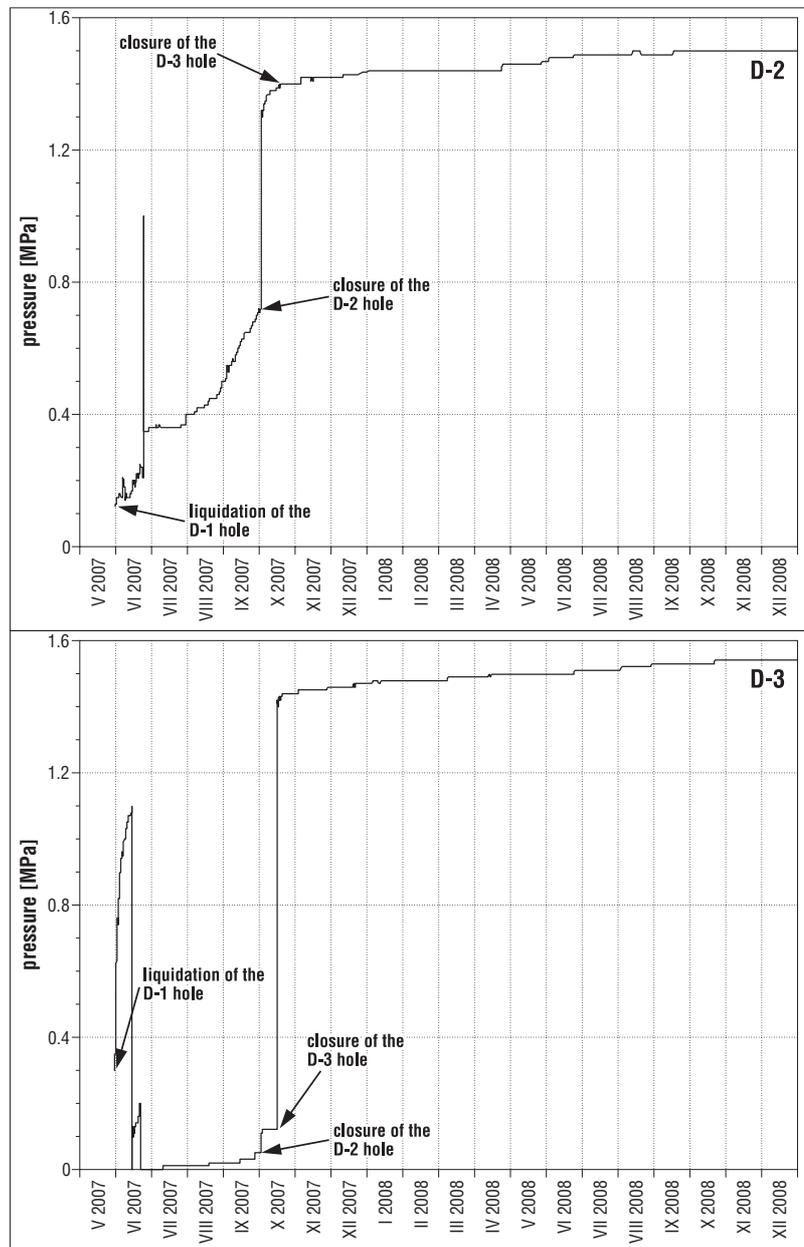
Fig. 8. Water pressure changes in the drainage holes D-2 and D-3 connected with liquidation of the inflow WIV-27 in the Mina crosscut

During the successive closure of leaks from the remaining drainage pipes, changes in the hydraulic head within the bed were observed. In the case of the D-2 borehole, some effects of liquidation of the D-1 hole were observed, which resulted in building up pressure by some  $0.6 \text{ MPa}$ . After the final closure of the D-2 hole, a sudden increase of pressure from  $0.7 \text{ MPa}$  to  $1.3 \text{ MPa}$  was observed. In the following phase, rebuilding the pressure in the D-2 borehole was slow and from the middle of October 2007 until the end of 2009 it increased by only  $0.2 \text{ MPa}$  (Fig. 8).

With regard to pressures observed in the D-3 hole, after the initial phase of changeable conditions in June 2007, no major effect of the liquidation of the D-1 drainage hole was observed over the subsequent few months. Even plugging the D-2 hole caused rather a small increase in water pressure in the D-3 hole (only by some 0.07 MPa). It was only after closing the D-3 drainage hole that a sudden increase in hydraulic pressure, over 5 hours only, from 0.23 MPa to 1.42 MPa was observed (Fig. 9). At the same time, hydraulic pressure measured in the D-2 hole was at 1.39 MPa. Similarly to the D-2 hole, starting from the middle of 2007 until the end of 2009, a continuous increase in pressure was observed in the D-3 hole, when it changed from ca. 1.4–1.42 MPa to 1.54 MPa (Fig. 8).

Changes in hydraulic pressure after closing the drainage pipes followed the same pattern in the case of both drainage holes. A large increase in pressure, by 0.6–1.2 MPa, was observed in the first stage. This phenomenon can be associated with flooding the volume of drainage pipes and free spaces in the vicinity of discharge zones. The next stage on the pressure curve (Fig. 8) is associated with the slow recovery of the water table in Chodenice sandstones.
